### GENERAL INFORMATION

Name of the project: Laurentino38, Roma (South)  
Design group: P. Barucci, A. De Rossi, L. Giovannini, C. Nucci, A. Sostegni  
Client: I.A.C.P. (now ATER Roma)

Construction: 1972 - 1983  
Sector: 100% social rented dwellings

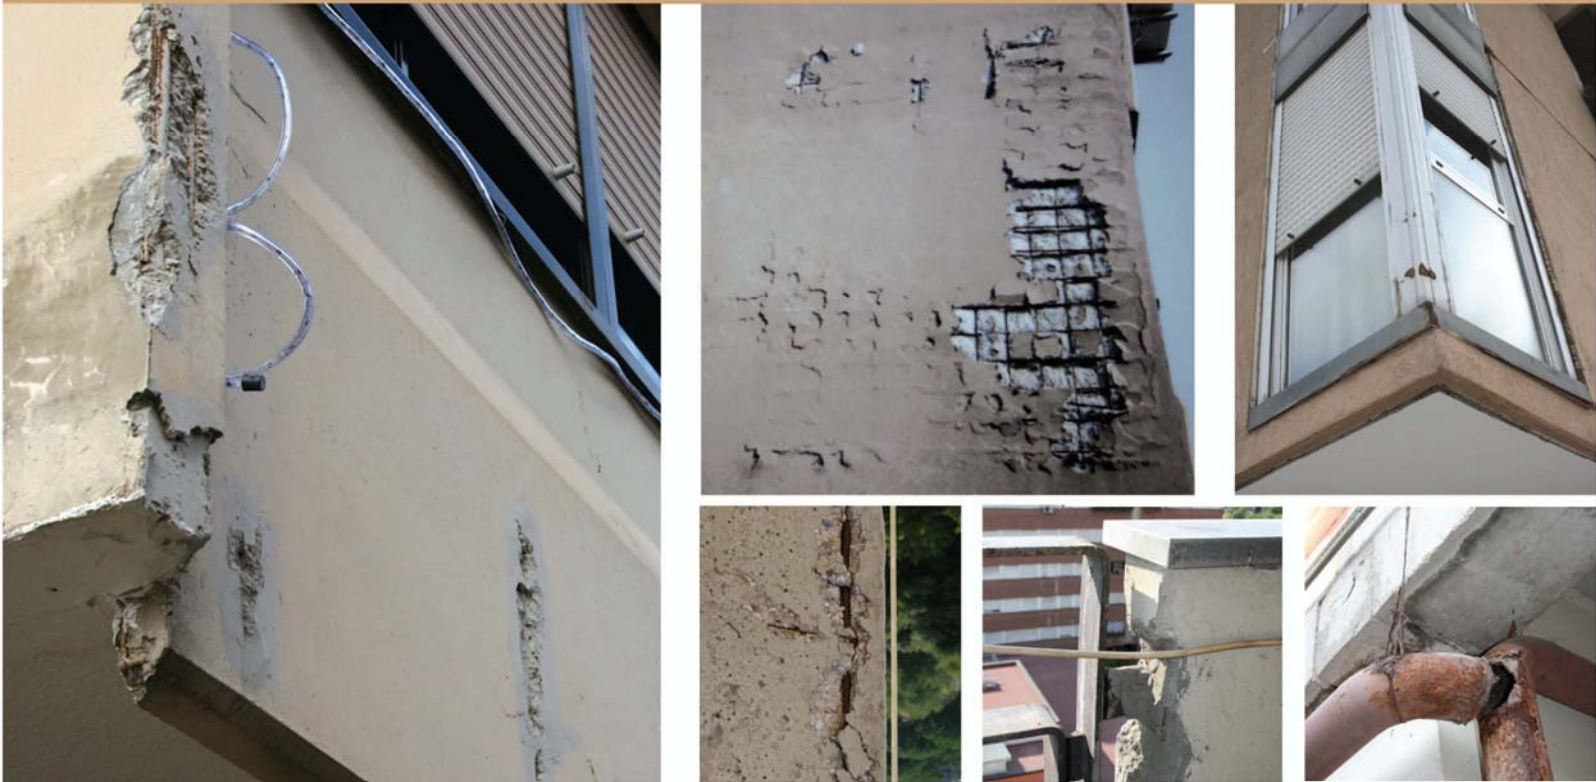
DECAY

Due to the absent-low quality maintenance over the years: crumbling of plaster, steel bars corrosion, removal of cladding, corrosion of window frames, and attack of biologic moulds.

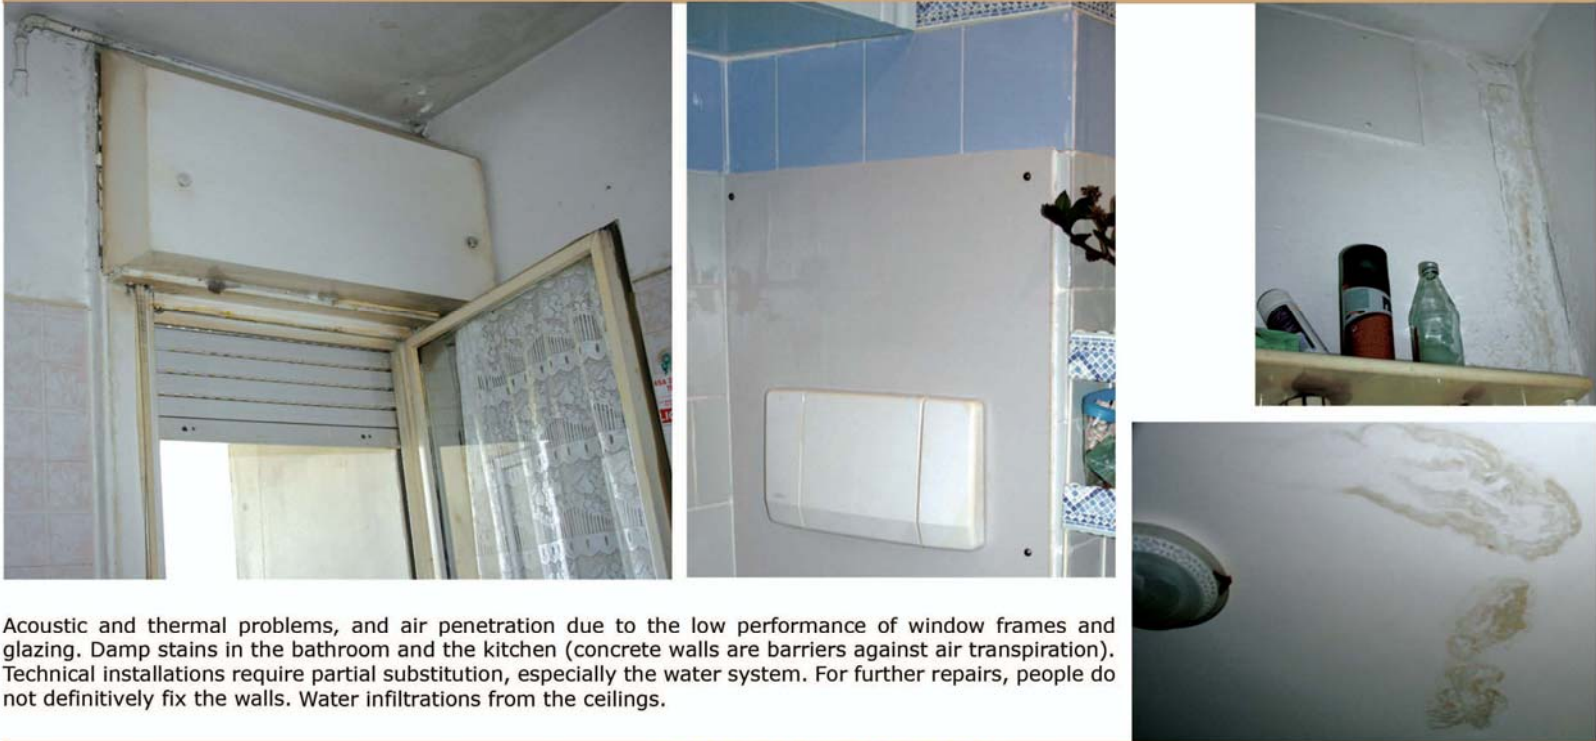
DWELLINGS

Acoustic and thermal problems, and air penetration due to the low performance of window frames and glazing. Damp stains in the bathroom and the kitchen (concrete walls are barriers against air transpiration). Technical installations require partial substitution, especially the water system. For further repairs, people do not definitively fix the walls. Water infiltrations from the ceilings.

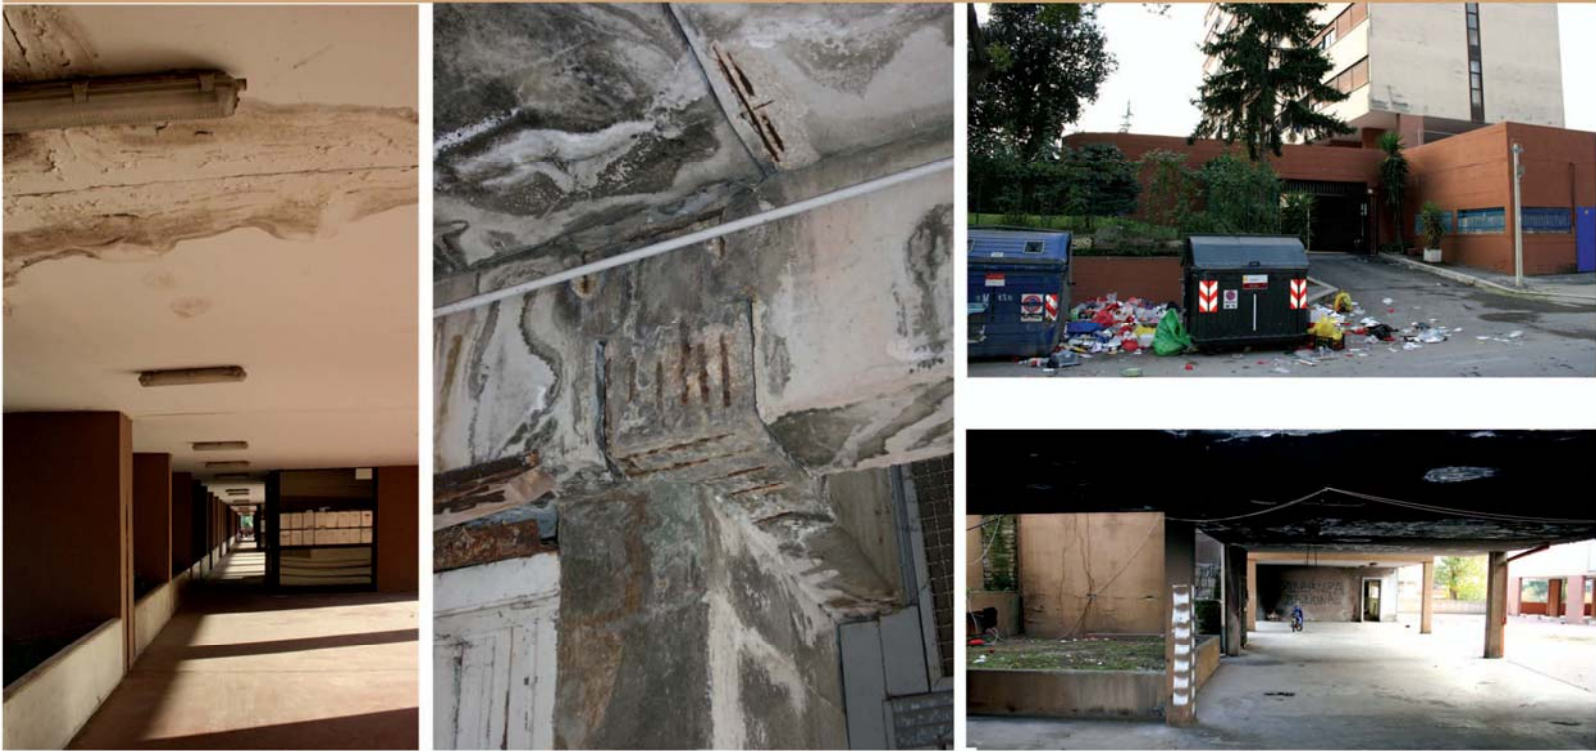
GROUND FLOOR

Similar physical deterioration occurs at the ground floor (entrances to the building, shared spaces) and in the parking garages.
