Politecnico di Bari

Ph.D. in Architecture: Innovation and Heritage  
XXIX Cycle

**Ph.D. Thesis in**  
Rehabilitation of the RC structures of the Brazilian heritage  
buildings with innovative techniques and materials

Jeferson Azeredo da Rosa

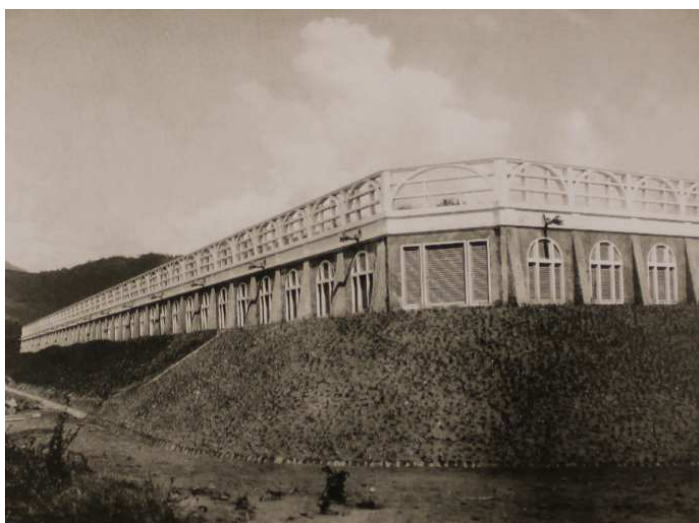
Figure 2.02 Water reservoir of the *Engenho de Dentro* (built in reinforced concrete, circa 1908)

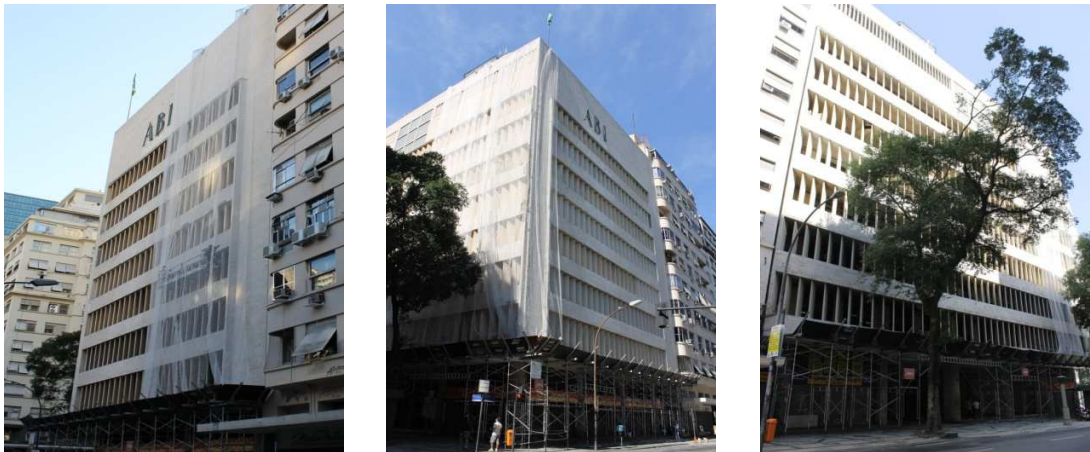
Figure 2.28 Photographs taken in July 2014, during the restoration works of the façades

In July 2014<sup>1</sup> the ABI went through restoration works on the façades (Fig. 2.28). Apparently, the building structure was in good condition, with few points of the concrete in deterioration process in initial stage and without presence of corrosion in the exposed steel bars (Fig. 2.29).

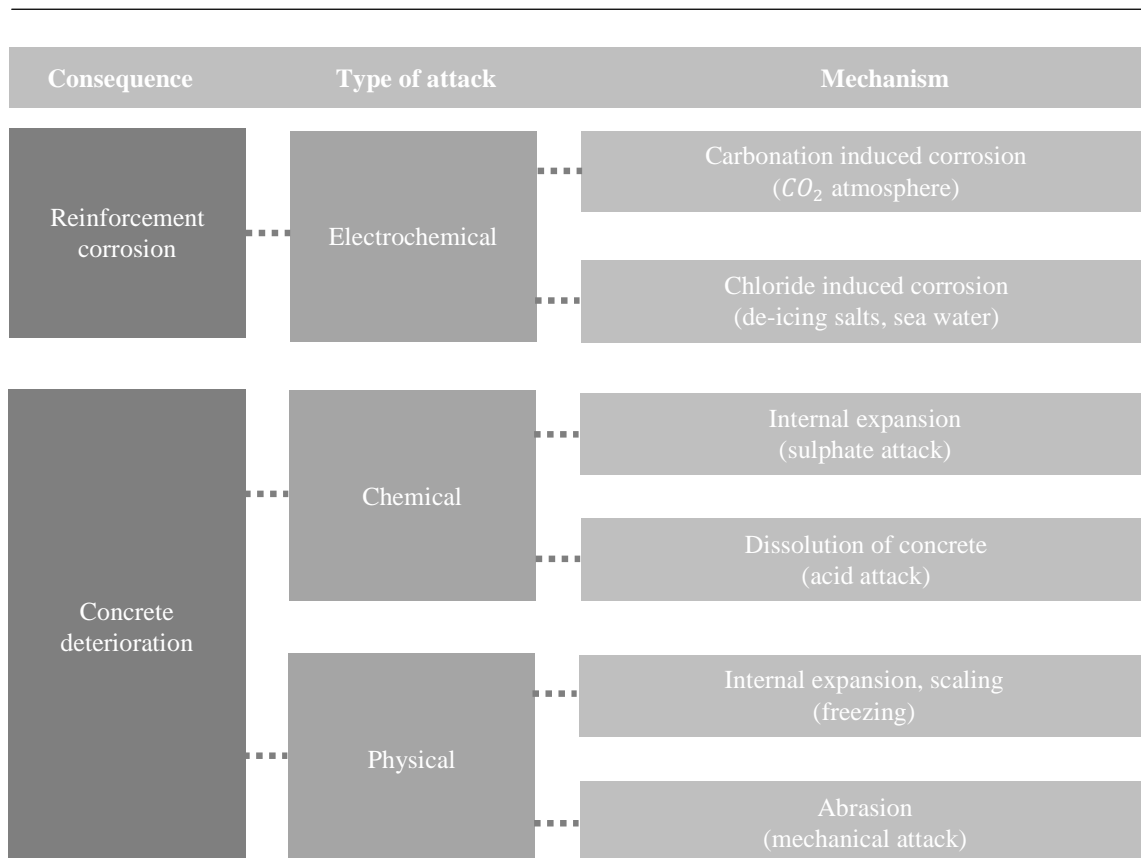
Figure 3.03 Deterioration mechanisms and consequences for reinforced concrete structures

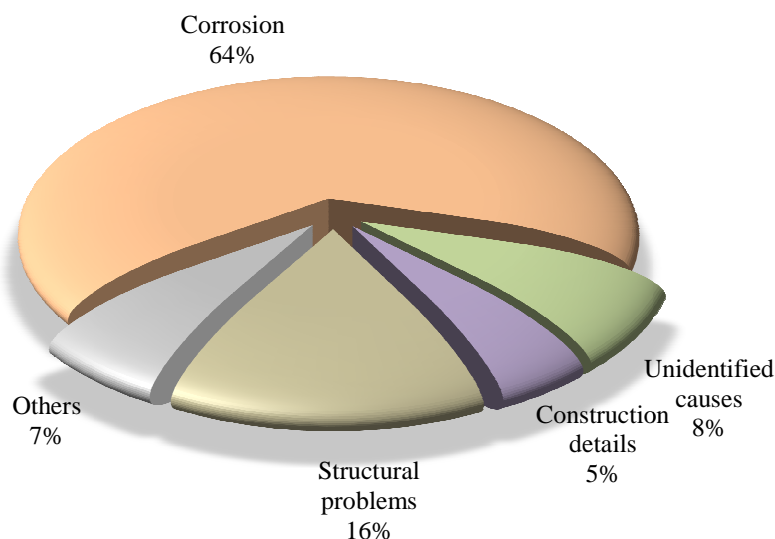
Figure 3.04 Main causes of damage to RC structures in the State of Pernambuco

aggressiveness level. Both carbonation-induced and chloride-induced corrosion are the main mechanisms of reinforcement corrosion on the Brazilian buildings<sup>1</sup>. A study by Andrade and Dal Molin (1997)<sup>2</sup>, about the main manifestations of structural damage of 189 buildings located in the State of Pernambuco<sup>3</sup>, shows that 64% of the structures presented deterioration problems caused by corrosion of reinforcement (Fig. 3.04).

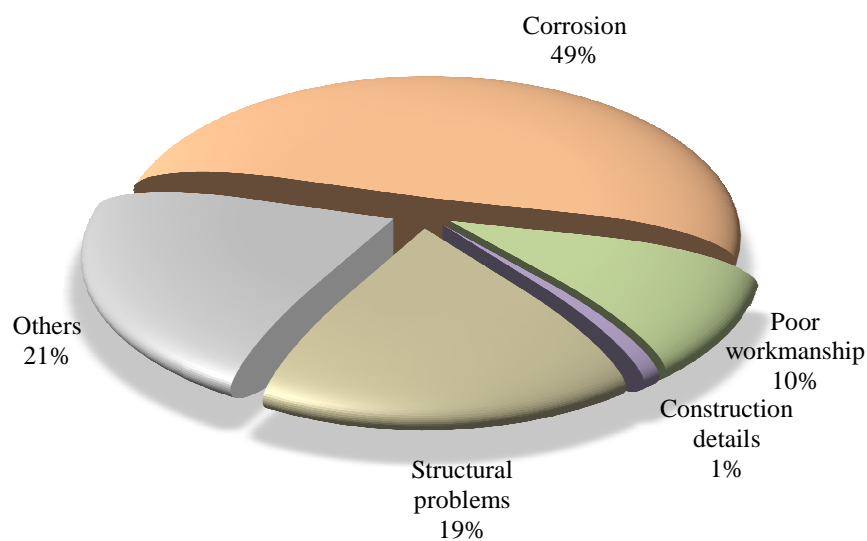
Figure 3.05 Main causes of damage to RC structures in the city of Rio de Janeiro

Another study made by De Oliveira A. and De Suoza V.<sup>1</sup>, on the types of reinforced concrete structures' deterioration of 541 buildings located in the city of Rio de Janeiro (using data from the municipal archive of the Department of Urban Planning of the Municipality of Rio de Janeiro), shows that 49% of the structures presented deterioration caused by reinforcement corrosion<sup>2</sup> (Fig. 3.05).

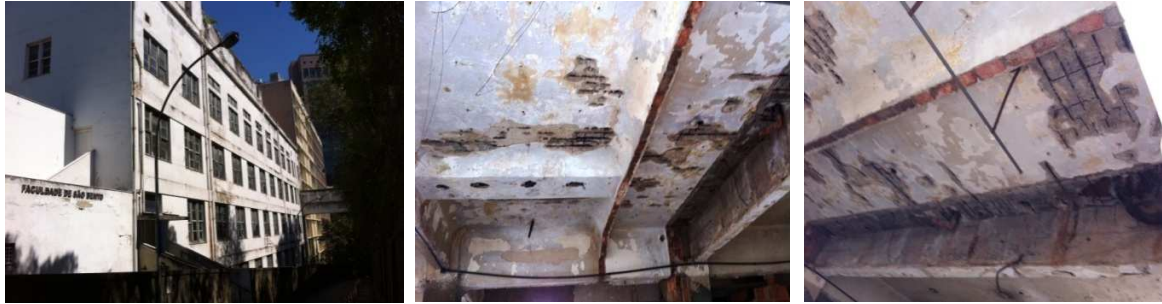
Figure 3.06 Deterioration of the slab of the 1st floor. Reinforcement corrosion and concrete spalling likely caused by chloride attack. Heritage building belonging to Monastery of *São Bento*, located in marine environment, in the center of Rio de Janeiro (photographs taken in July 2014)

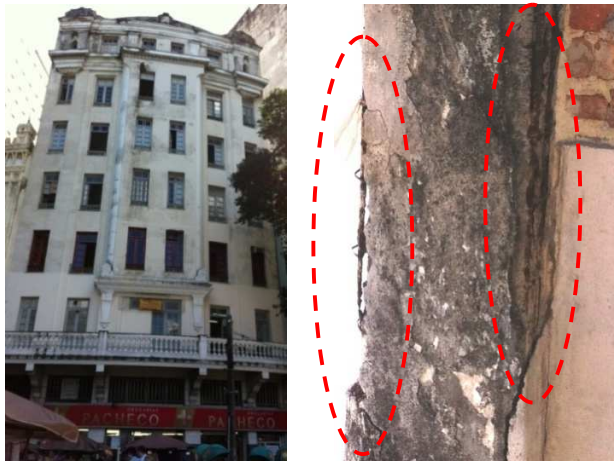
Figure 3.07 Deterioration of the columns of the *Rua do Passeio* building, built in the 30s in the center of Rio de Janeiro. Concrete spalling and reinforcement corrosion likely caused by chloride attack. Extreme case of deterioration with breaking of longitudinal and transverse bars of the external columns (photographs taken in July 2014)

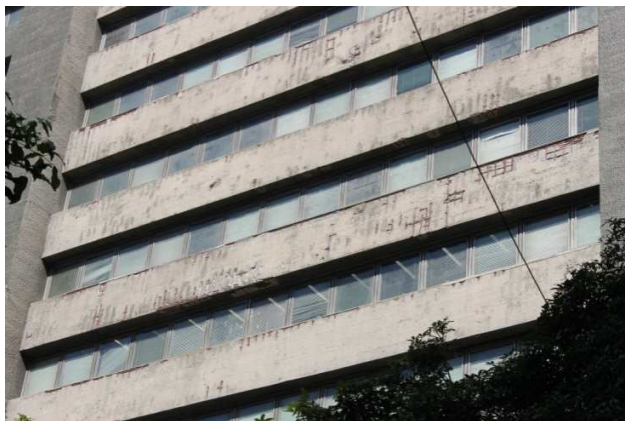
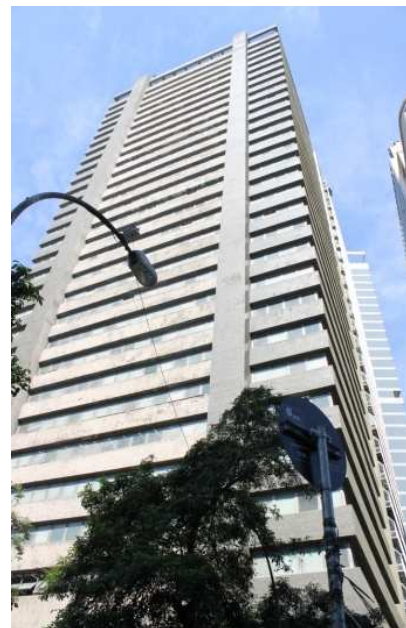
Figure 3.08 Steel corrosion and concrete spalling of columns and beams likely caused by carbonation of concrete (most likely occasioned by having a small layer of concrete cover for reinforcement). *Rua Nilo Peçanha* building, built in the 50s in the center of Rio de Janeiro (photographs taken in July 2014)

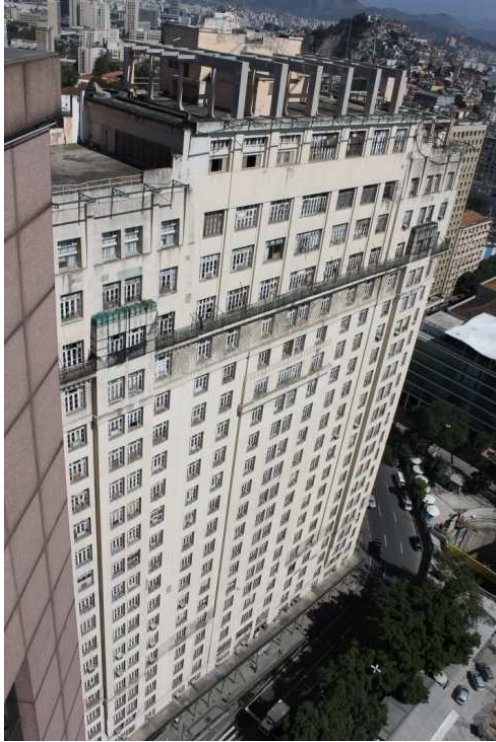
Figure 3.09 Structural deterioration of the ground floor and roof floor. Concrete spalling and steel corrosion with cross-section loss of the transverse and longitudinal reinforcement, likely caused by chloride attack. A *Noite* building, built in 1929, located in the marine environment, in the center of Rio de Janeiro (photographs taken in July 2014)

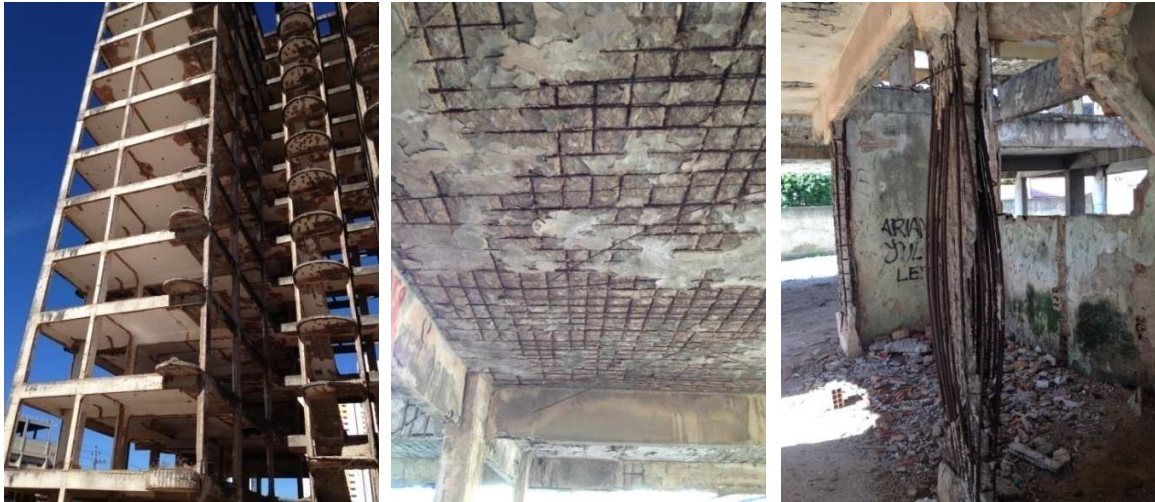
Figure 3.11 Structure in terminal state of deterioration caused by chloride attack. Extreme case of steel corrosion and concrete disintegration. Building located in the marine environment in Fortaleza city (photographs taken in May 2015)

The figure below shows the advanced state of deterioration of the structure of a building out of use, located in the city of Fortaleza, capital of Ceará State.

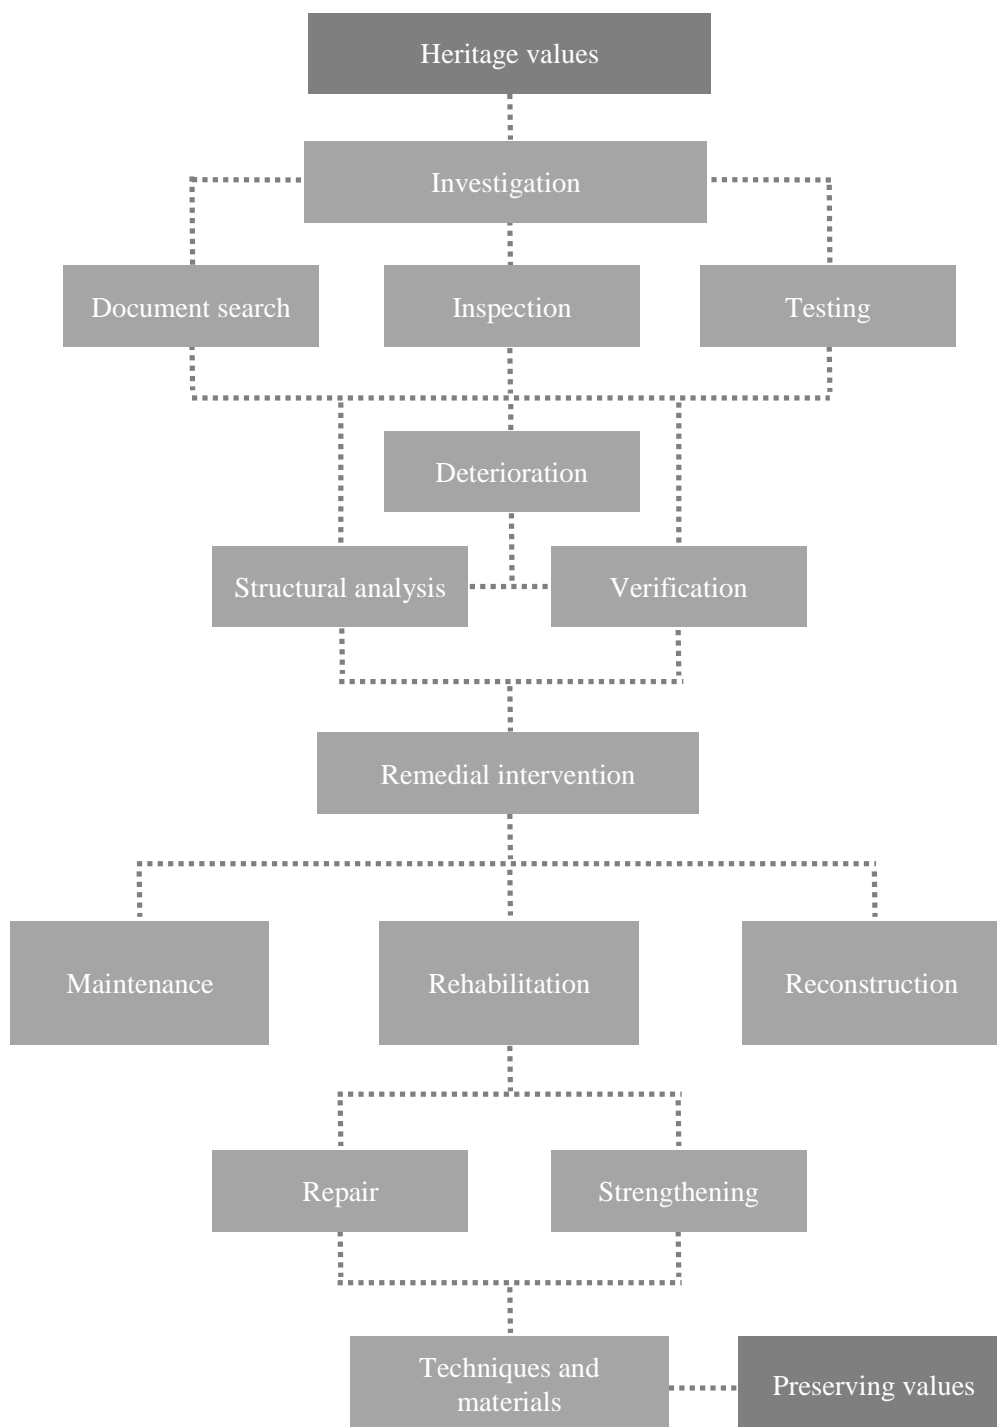
Figure 4.01 Model proposal of assessment hierarchy for the rehabilitation of deteriorated heritage structures

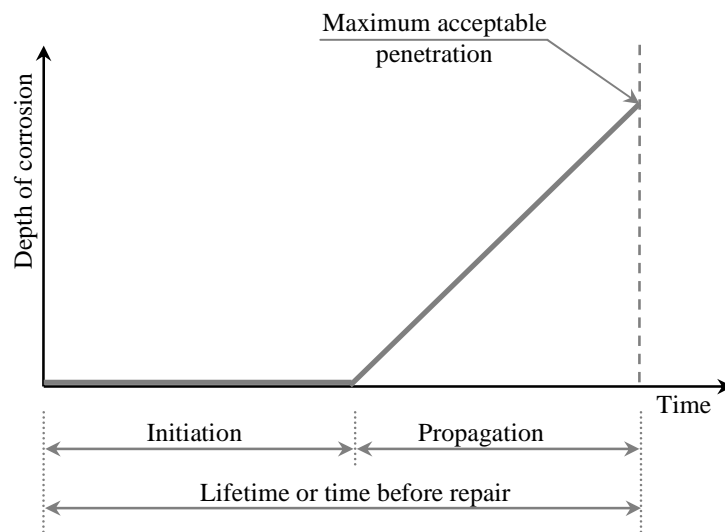
Figure 4.03 Initiation period and propagation period of corrosion in RC structure (adapted from Tuutti model)

The propagation period by chloride-induced corrosion is reduced regarding the propagation period of the carbonation-induced corrosion. In the calculation of the lifetime of structures in contact with environment containing chlorides, the propagation period of corrosion may be neglected and considered equal to initiation period<sup>1</sup>.

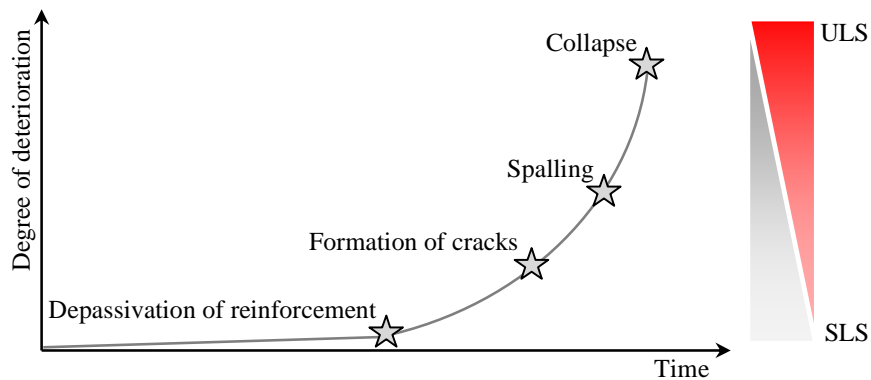
Figure 4.04 Damage of a reinforced concrete structure due to corrosion (adapted from *fib Bulletin 59*)

The figure below shows the evolution of deterioration over time of a reinforced concrete structure subject to corrosion.

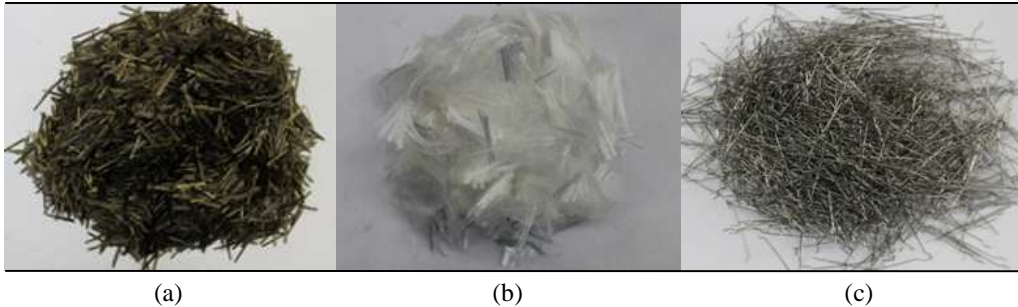
---

Figure 6.01 (a) Basalt micro-fiber; (b) Polyethylene micro-fiber; (c) Hooked Stainless Steel fiber

This chapter deals with the mechanical properties assessment of HPFRCC mixtures designed with locally available materials. In particular, different HPFRCC mix designs were considered with a very compact cementitious matrix reinforced with three different types of microfibers: basalt fibers, high density polyethylene fibers and hooked stainless steel fibers (Fig. 6.01), considering 1% or 2% of the volume contents. The influence of the fiber contents on the compressive and tensile strengths, the strain-hardening performance and the fracture energy are discussed.

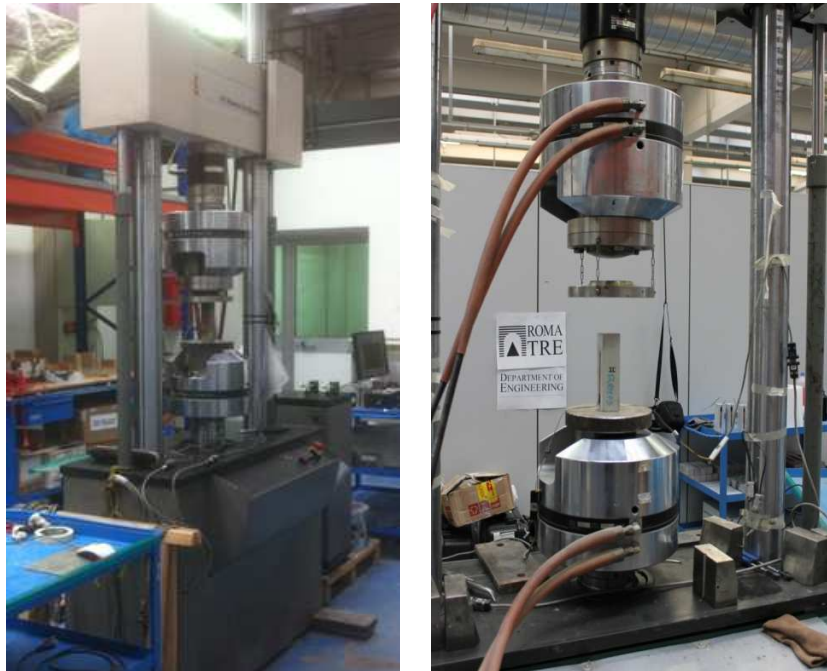
Figure 6.09 Universal Testing Machine MTS

adopting the loading system applied by means of a having a load capacity of 500 kN. The tests were carried out at a constant displacement rate of 0.005 mm/s.

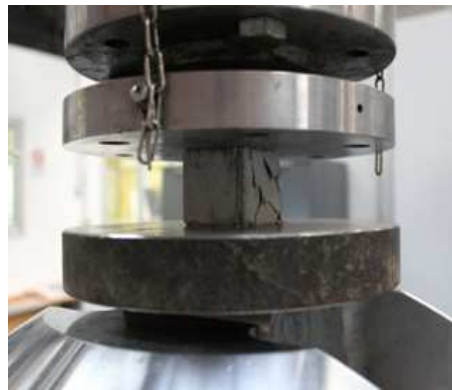
Figure 6.12 Compressive strength test

In Figure 6.13 are presented the results of compressive strength of cubic specimens for each batch of mixtures. The compressive strength of basalt and polyethylene fiber mixtures (B1, B2, P1 and P2) were reduced in 8%, 4%, 30% and 31%, respectively, compared to the plain cementitious matrix (R0). The incorporation of 1 vol.% and 2 vol.% of stainless steel fibers improved the compressive strength in 28% and 35%, respectively.

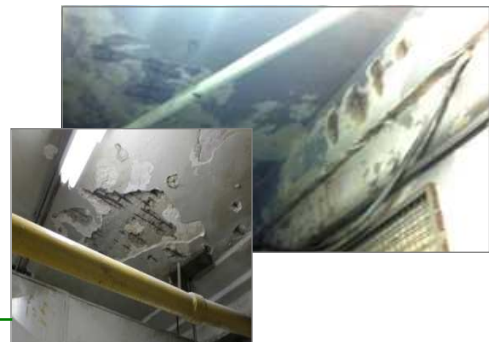
Figure 7.04 (b) Ground floor: damaged RC beam and slab by reinforcement corrosion and concrete spalling

In July 2014 was carried out a preliminary inspection with visual examination, photos of various points of structural degradation, in the interior and exterior of the building, were taken. Figures 7.04 and 7.05 show visible points of concrete spalling and reinforcement corrosion<sup>1</sup>, some in advanced process with loss of cross-section probably caused due to presence of moisture in the slab. The nature of the damages does not exclude the possibility of chloride attack (according to the Brazilian standard the building is located in a high environmental aggressiveness zone – marine zone n. III). Inadequate concrete covers in the damaged parts were also identified (at odds with the current standards).

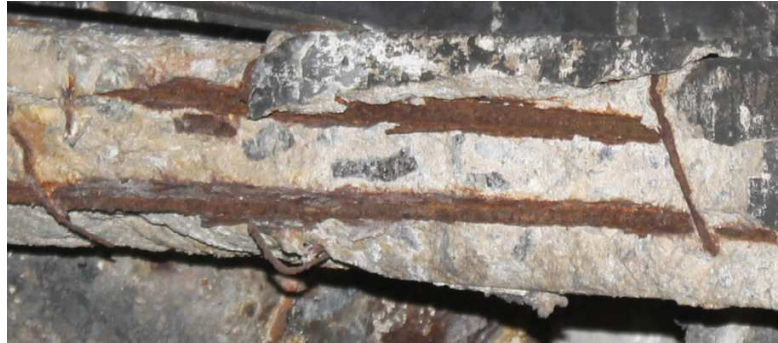
Figure 7.06 Damaged RC beam by reinforcement corrosion, in advanced state. With loss of longitudinal bars cross-section, transverse reinforcement broken and loss of concrete cross-section by spalling

Numerical simulation of reinforced concrete beam damaged by corrosion was performed to evaluate the performance level in terms of bearing capacity. The investigation was carried out by numerical example of a damaged beam located in the roof floor of the *A Noite* building (Fig. 7.06).

To carry out the preliminary inspection inside the building only a visual inspection was allowed, for that reason it was not possible to obtain more details of materials and dimensions of the structural elements, as well as the level of degradation and depth of reinforcement corrosion. Thus, to achieve an approximate preliminary study on the analyses of performance evaluation of the degraded structure, estimated values for the beam section, diameter of longitudinal bars and cross-sectional loss were used. The same applies to material mechanical properties, as shown in Table 7.01.

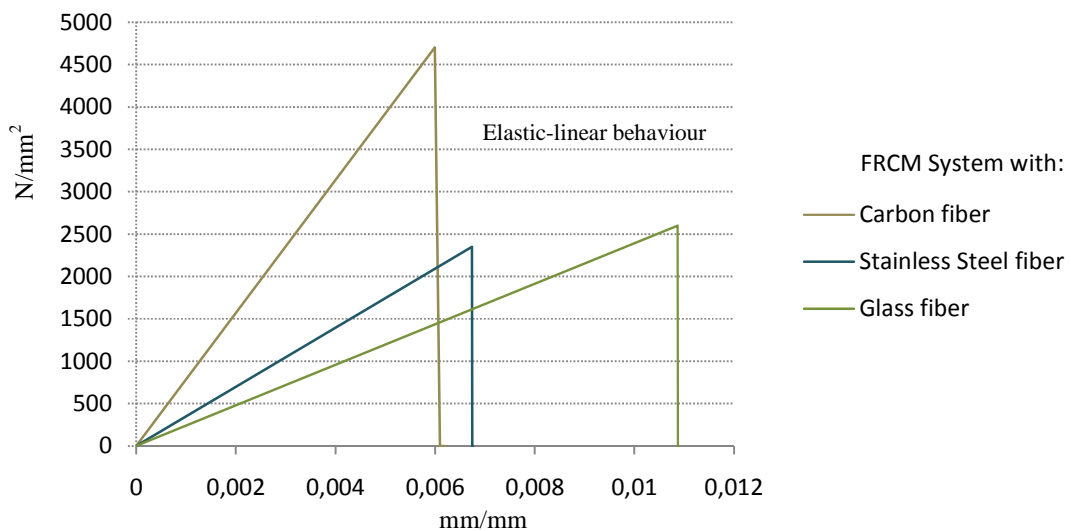
Figure 7.25 FRCM System Stress-Strain curves for analyses with fiber model in *OpenSees* Software (elastic-linear tensile behaviour)

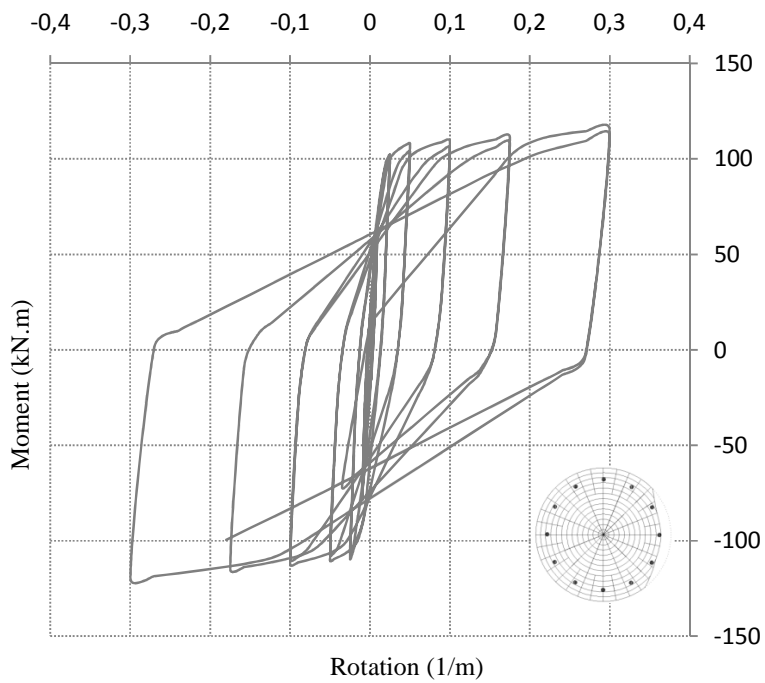
Figure 7.56 Cyclic analysis: Damaged RC section (current time)

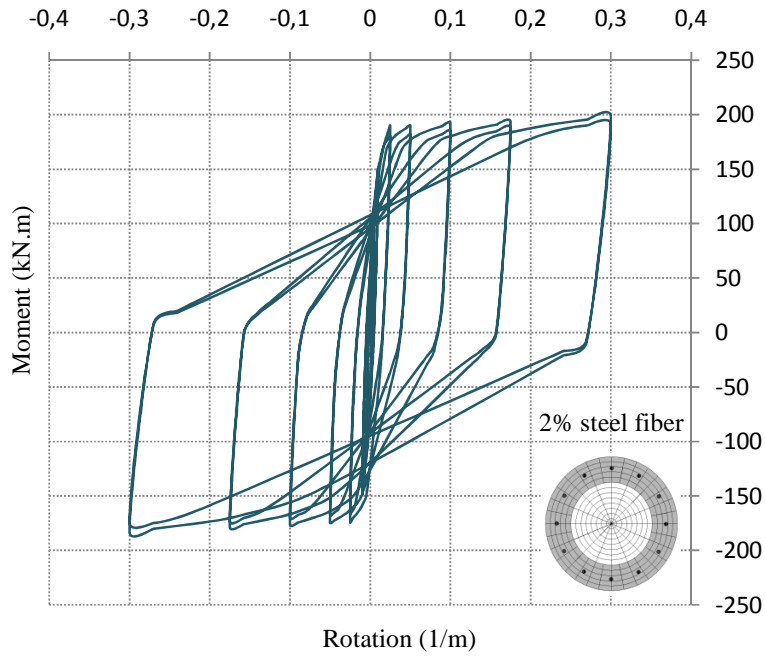
Figure 7.69 Cyclic analysis: strengthened column section with HPFRCC (2% stainless steel fiber)

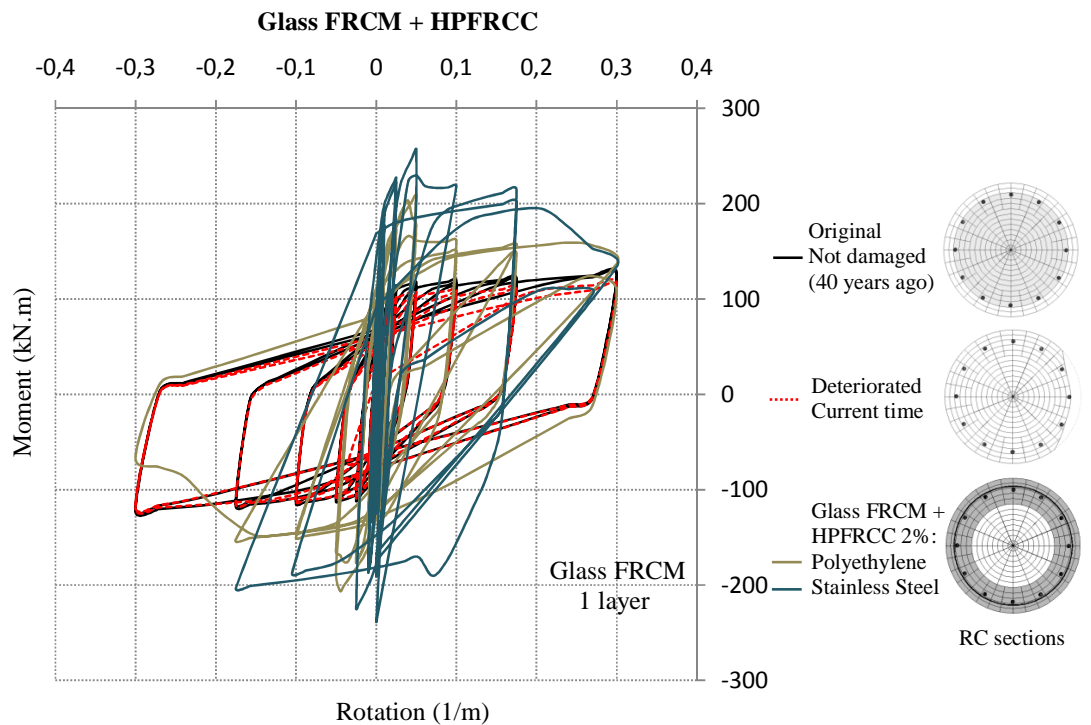
Figure 7.93 Cyclic analysis: strengthened column section with combined Glass FRCM 1 layer + HPFRCC fibers vol. 2% (8.0cm of layer)
