DOTTORATO DI RICERCA IN INGEGNERIA CIVILE

"Strengthening of masonry vaults with Steel Reinforced Grout"

Francesca Roscini

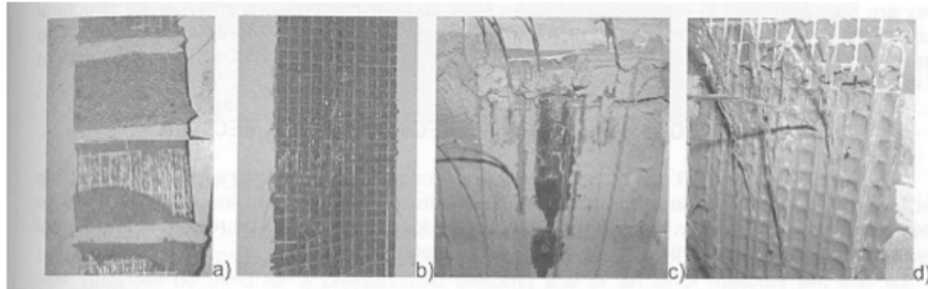
Figure 2.1. Type of failure [Cancelli et al., 2007]

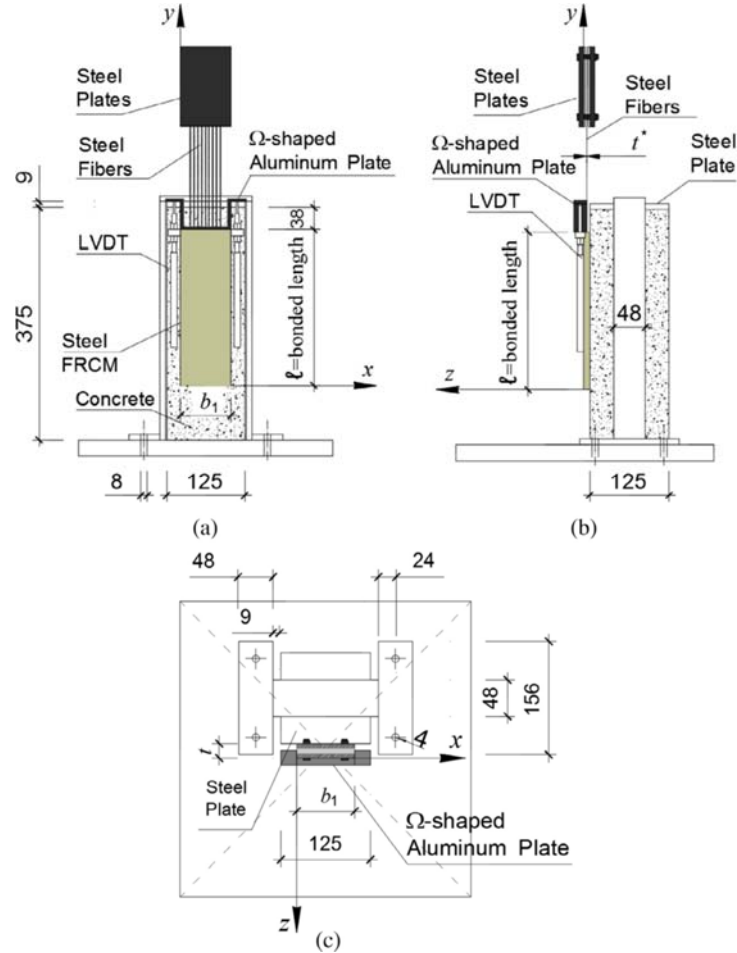
Figure 2.2. Single-lap direct-shear test set-up (a) front view, (b) side view, and (c) top view (dimensions in mm) [Sneed et al., 2016]

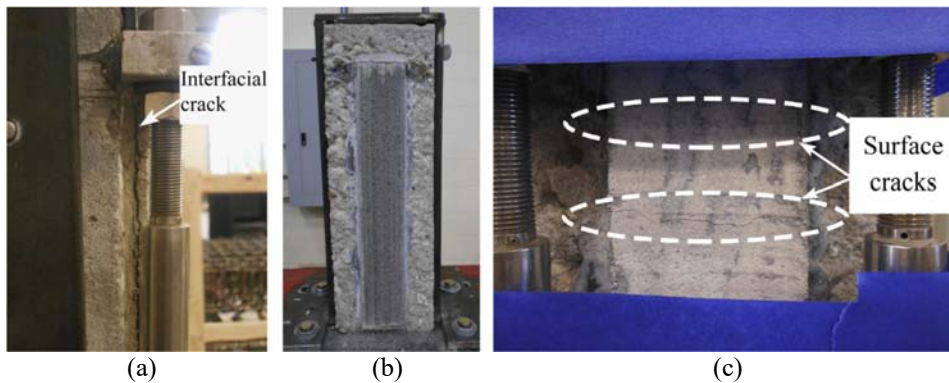
Figure 2.4. Pictures of single-lap shear test specimens: (a) crack along interface of cords and matrix, (b) surface of internal matrix layer after failure (specimen DS_K_330_50_1 shown), and (c) cracking observed on surface of external matrix layer [Sneed et al., 2016]

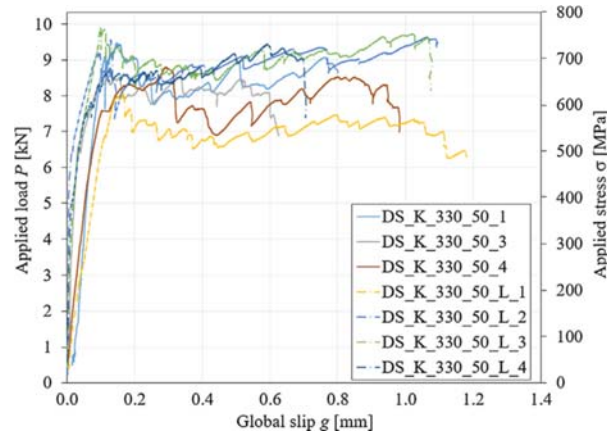
Figure 2.5. Applied load P – global slip g response and applied stress σ – global slip g response of single-lap direct-shear specimens [Sneed et al., 2016]

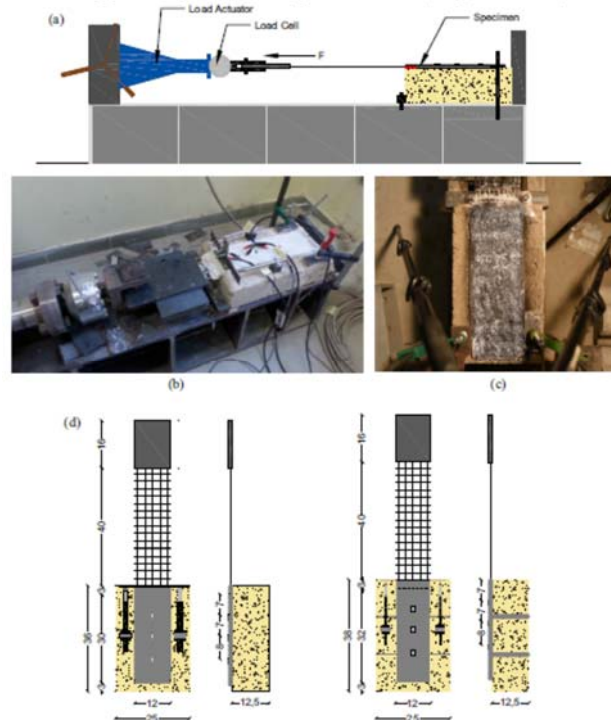
Figure 2.6. a) Experimental set-up for push-pull bond test; b) example of specimen positioned in the testing apparatus; c) painted surface of the matrix for DIC; d) position of strain gauges and LVDTs for specimens made of single tuff stone e prisms [Bilotta et al., 2017]

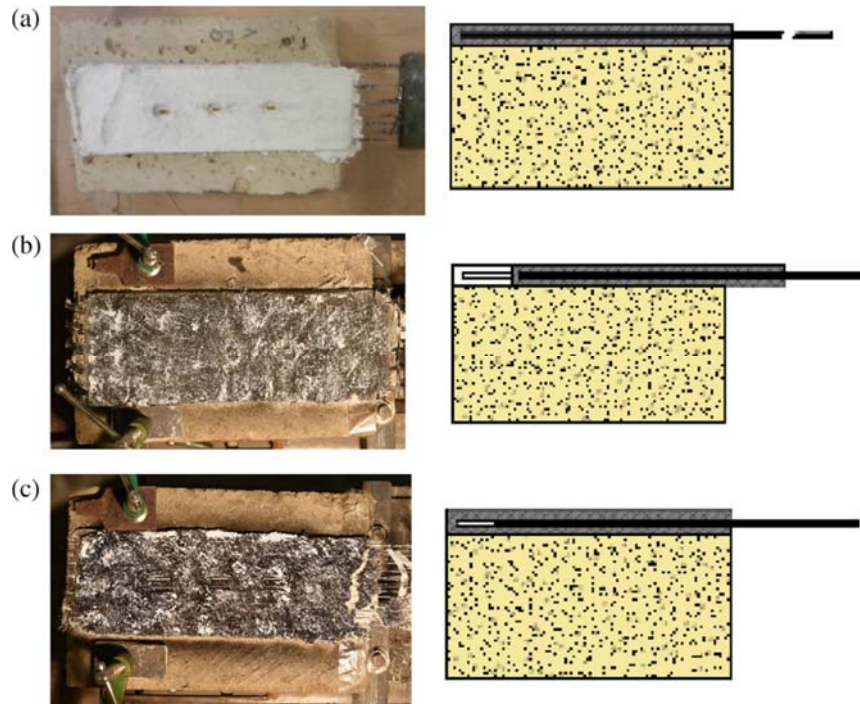
Figure 2.7. Failure modes: a) tensile failure of the glass fibers; b) debonding at the tuff-matrix interface; c) slippage of the fibers from the matrix [Bilotta et al., 2017]

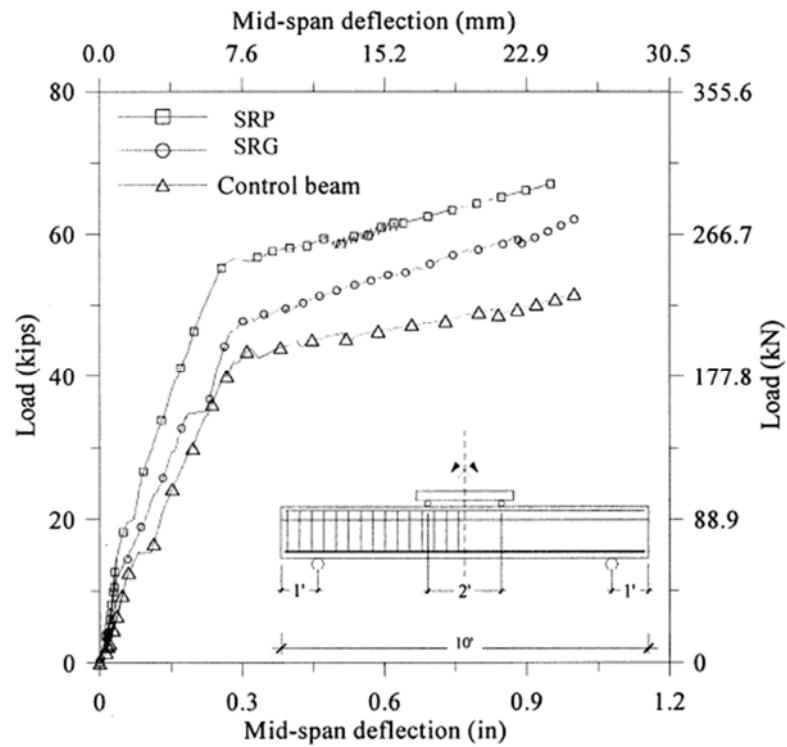
Figure 2.10. Load-midspan deflection of reinforced concrete beams with and without SRG strengthening elements [Huang et al., 2005]

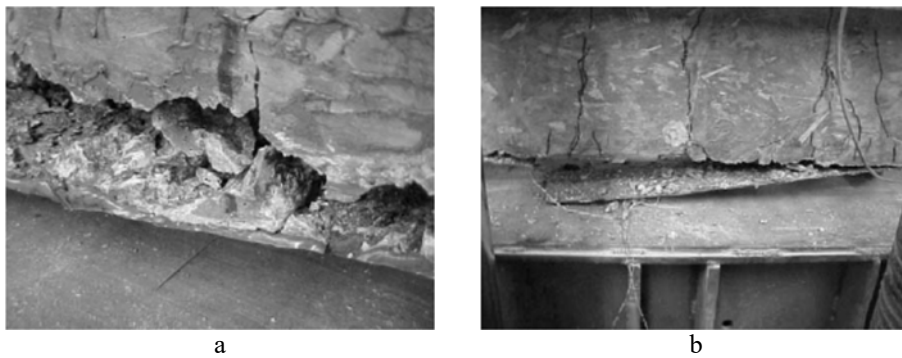
Figure 2.11. Failure of SRG strengthened reinforced concrete beams. SRP (a), SRG (b) [Huang et al., 2005]

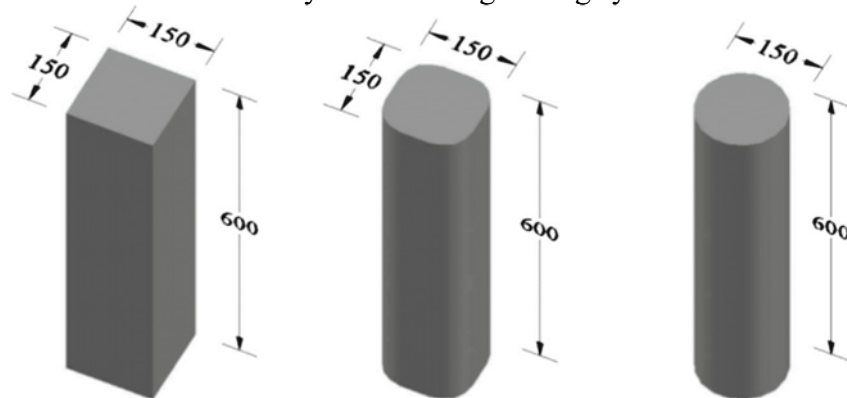
Figure 2.14. Specimen geometry and cross section shapes (dimensions in mm)
[Thermou et al., 2016]

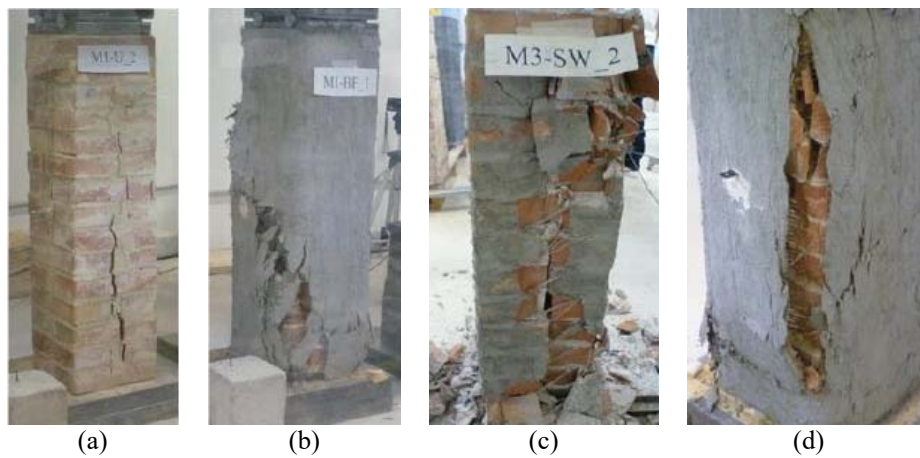
Figure 2.19. Failure mode for clay brick masonry columns: (a) unconfined; (b) confined with BFRCM wraps; (c) reinforced by steel wire collaring. (d) Tensile fracture of the basalt fiber mesh. [Fossetti et al., 2016]

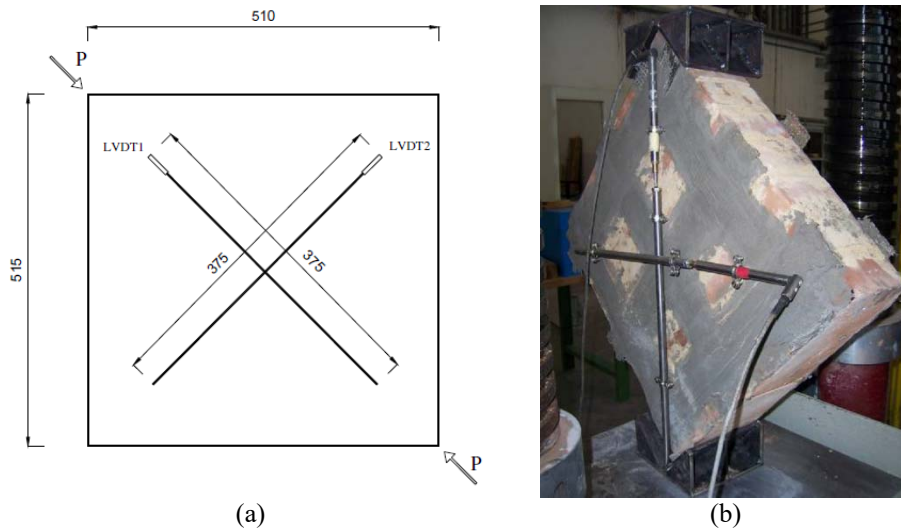
Figure 2.20. Geometrical configuration and boundary conditions for masonry panels tested in diagonal compression [Borri et al., 2011]

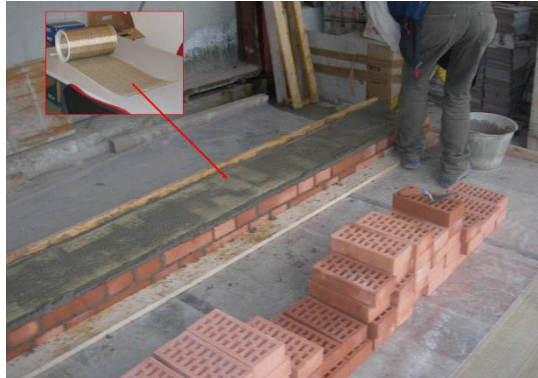
Figure 2.21. Ring – beams built by perforated bricks and SRG laminates [Borri et al., 2010]

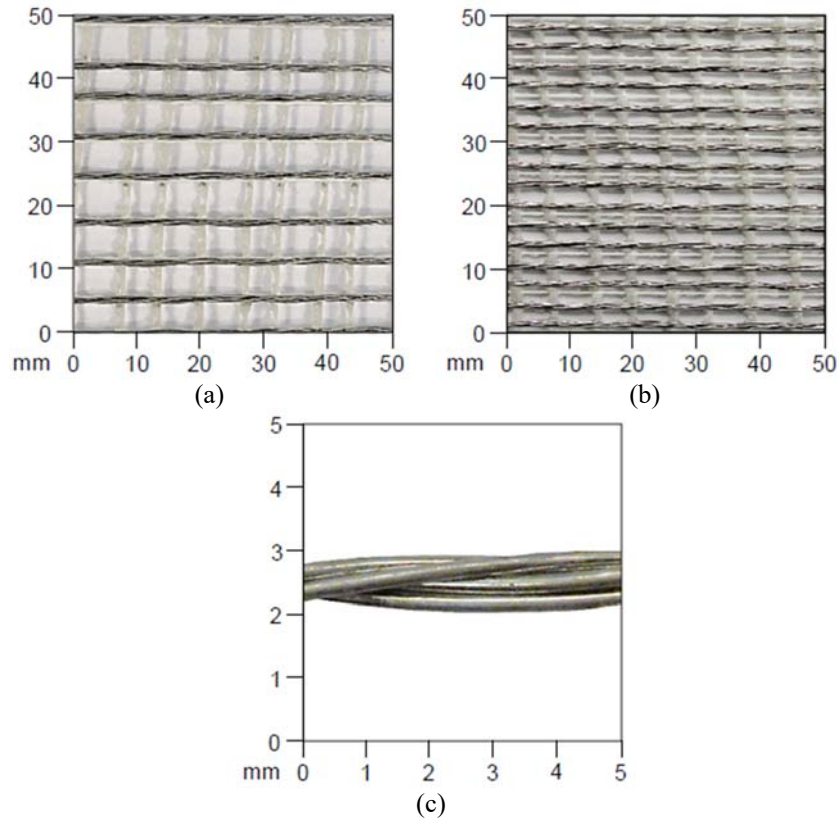
Figure 3.2. Steel mesh having 0.108mm² cross section area (a), steel mesh having 0.2016 mm² cross section area (b) and architecture of an individual strand(c)

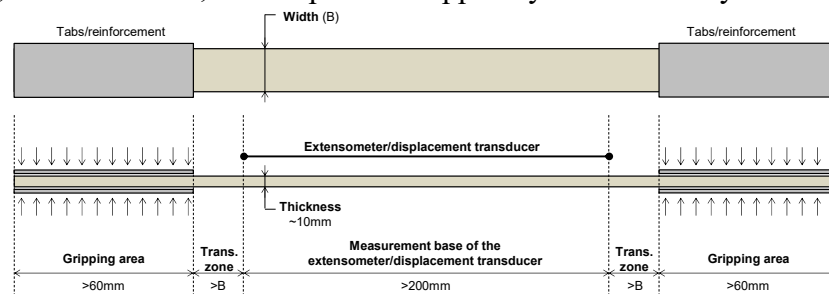
Figure 4.2. FRCM specimen geometry (the measures are only advised)

Composite materials coupons subjected to direct tensile tests are manufactured, according to RILEM TC-250 CSM procedures (Figure 4.2), with Perspex moulds, kept wet for 2 days, cured at 95% R.H. for 24h. After demoulding, cured in water for 27 days (under small weights), stored on a plane surface «lying sideways on» and on supports for uniform drying and, finally, left for 15 days in laboratory conditions (18–20°C temperature and 50–60% RH) before testing. At the end of this casting process, coupons are made (Figure 4.4). In order to prevent early failures, it is very important that, at its last sides, the coupon is wrapped by two GFRP layers.

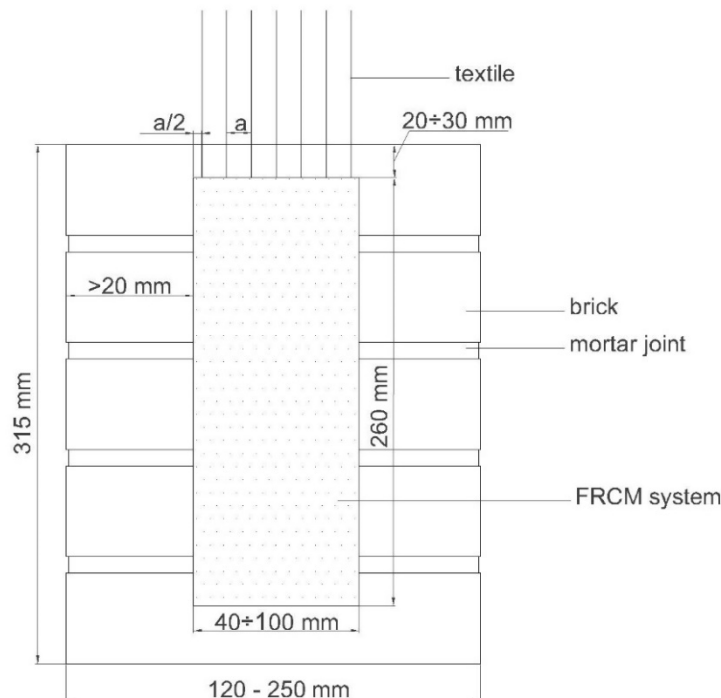
Figure 4.3. FRCM reinforcement applied on brickwork masonry geometry

For shear bond tests, following RILEM TC-250 CSM procedures (Figure 4.3), masonry prisms are built having 12cm×12cm base, kept wet for 15 days and stored in laboratory conditions (18–20°C temperature and 50–60% RH) for 15 days. Reinforcements are applied with aluminium moulds and kept wet for 2 days. After demoulding, specimens are wetted for 26 days and stored in laboratory for 15 days before testing (Figure 4.5). Aiming at ensure a good clamping, two aluminium tabs are applied at the last side of the textile, in accordance to UNI EN 2561 recommendations [UNI EN 2561]. It is necessary to underline the importance of ensuring adequate curing conditions on FRCM systems after manufacturing of specimens for both tensile and shear bond tests. In particular, curing under wet conditions prevents the mortar matrix from drying out and the development of any cracking phenomena. Wet conditions have also to be ensured, given the high porosity of clay masonry which will absorb the moisture from the mortar matrix. Therefore, curing of specimens under wet conditions is strictly recommended upon the completion of both brickwork manufacturing and FRCM strengthening application, in order to ensure an effective stress-transfer mechanism at the reinforcement/substrate interface and to avoid premature failure.

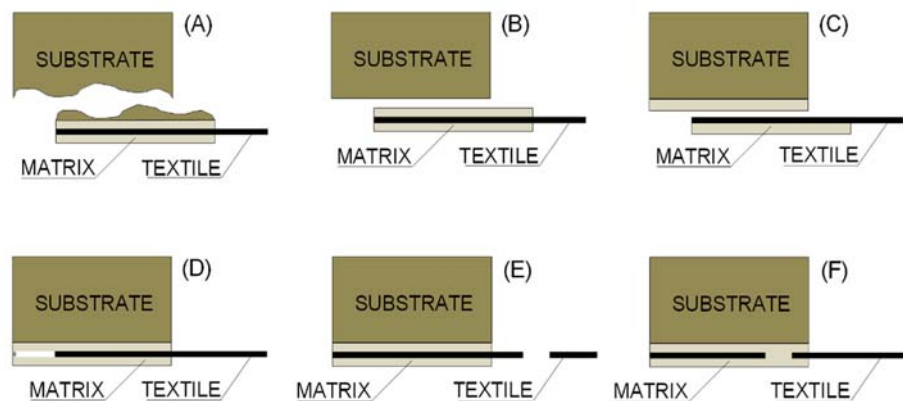
Figure 4.10. Shear bond test failure modes [de Felice et al., 2014 -Ascione et al. 2015]

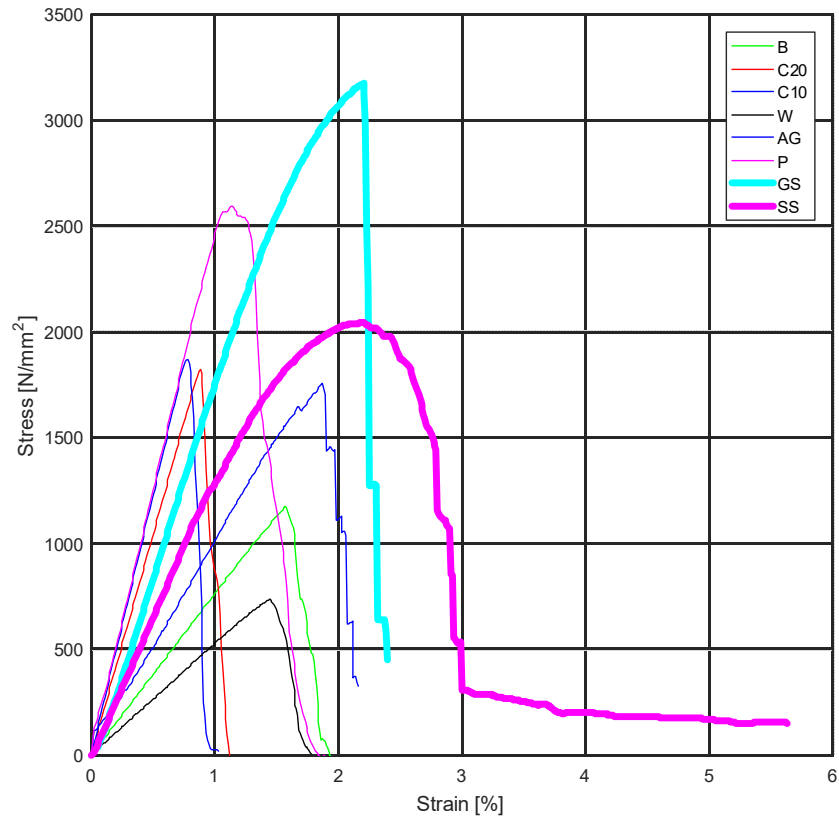
Figure 4.21. Stress-Strain graphs for textile tensile tests (average values)

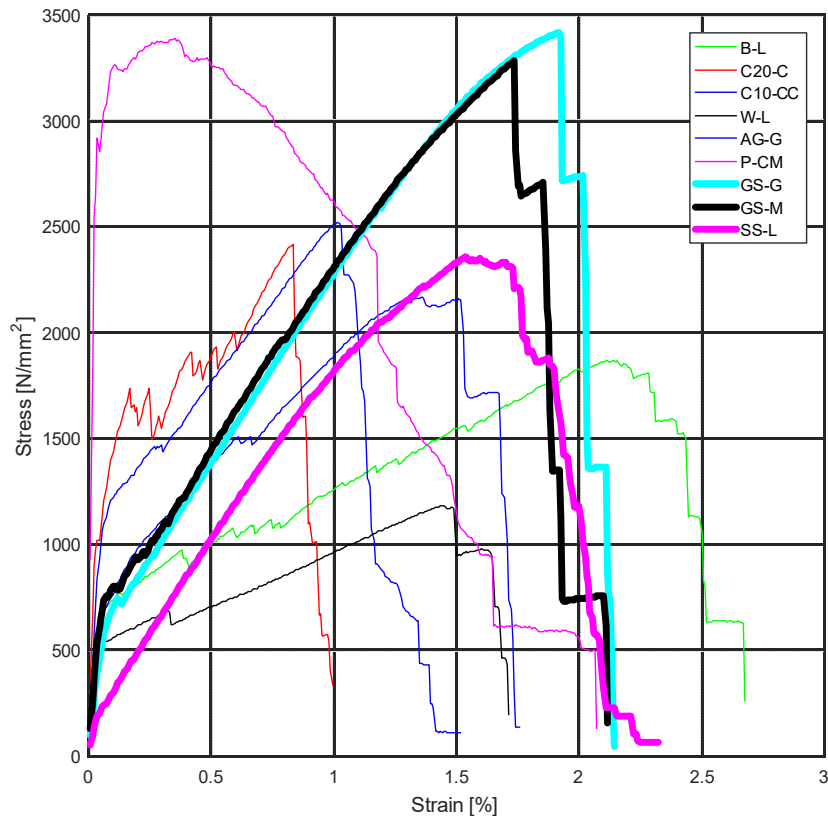
Figure 4.22. Stress-Strain graph for direct tensile test on composite material specimens (average values)

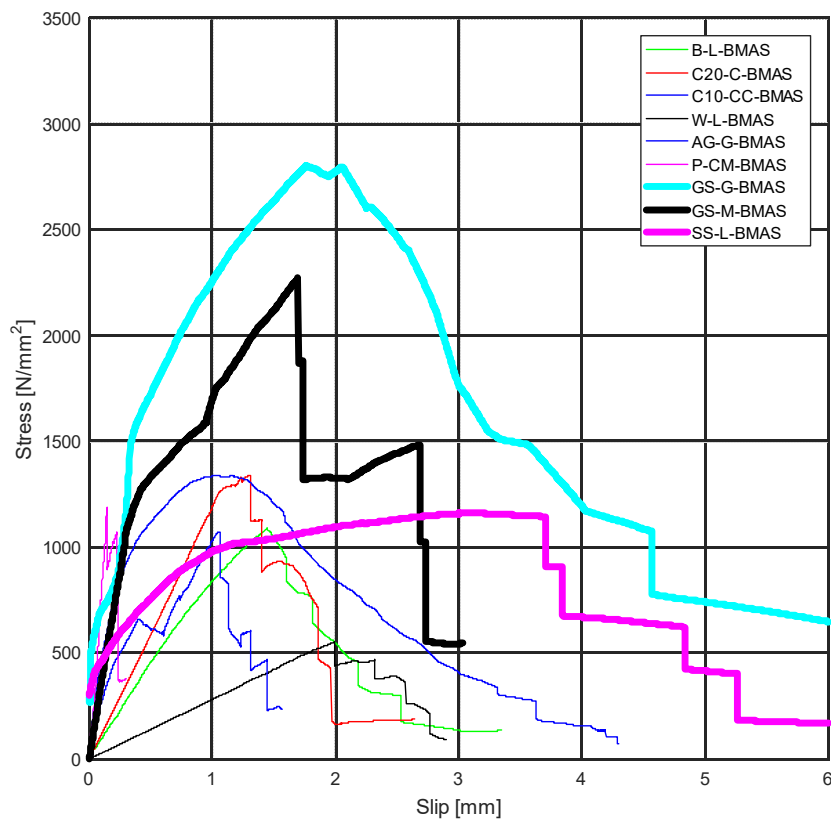
Figure 4.23. Stress-Slip graph for shear bond tests results (average values)

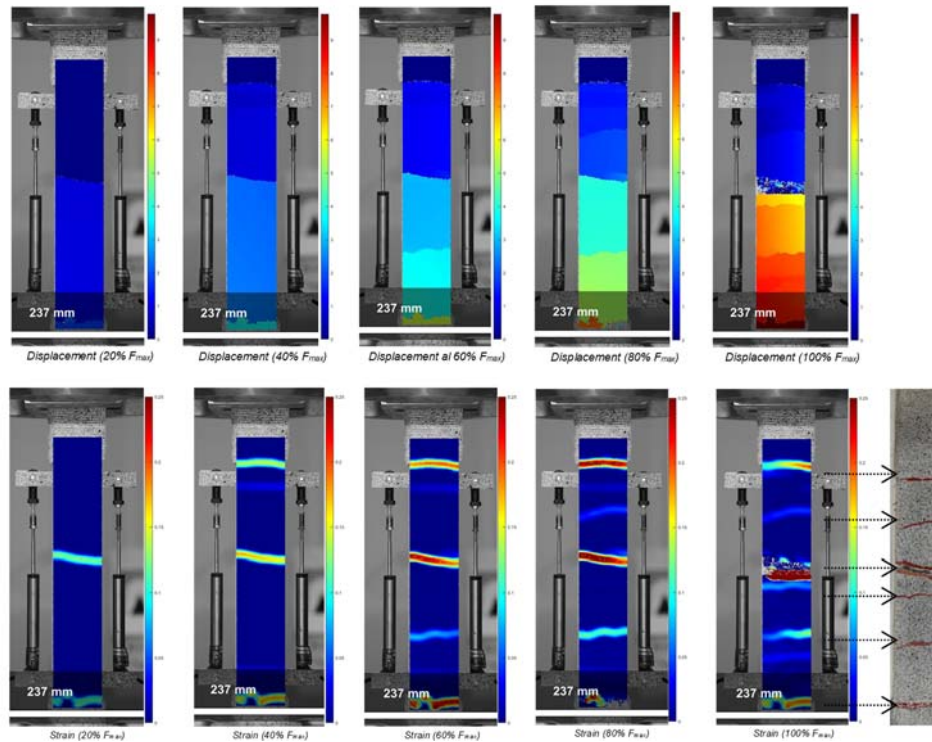
Figure 4.27. Displacements and strains development plot for coupons tensile test

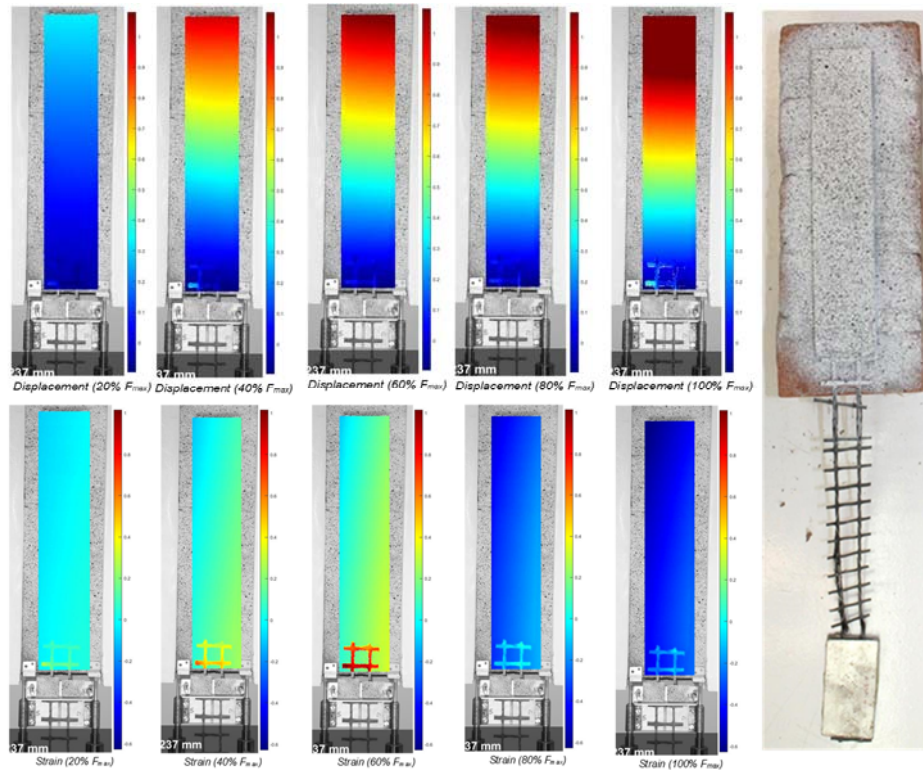
Figure 4.28. Displacements and strains development plot for shear bond test

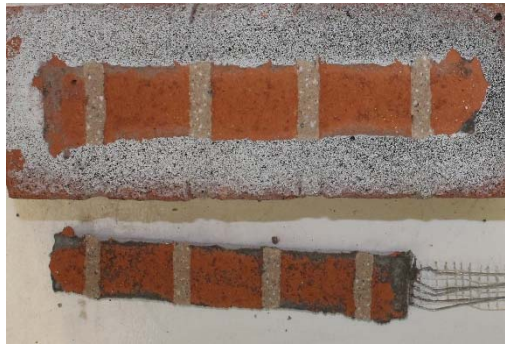
Figure 4.30. Detachment at the interface mortar-masonry substrate

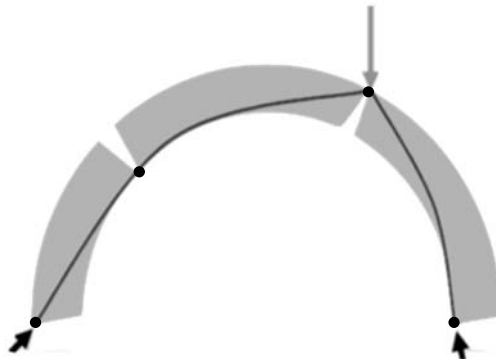
Figure 5.1. Hinges kinematic collapse, in asymmetric load condition

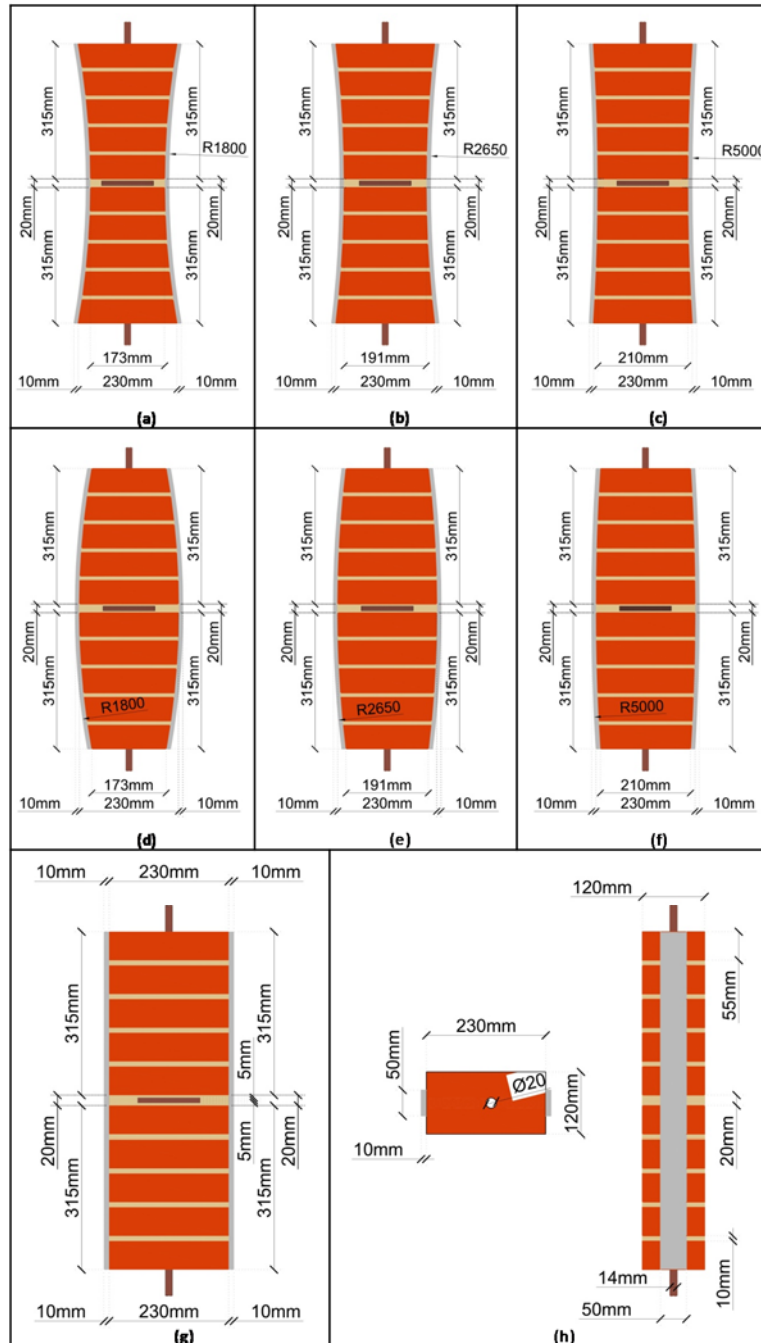
Figure 5.15. Lateral view (a-g) and bottom and side view (h) of the specimens under investigation with concave (a-c), convex (d-f) and plane (g) surface for double-lap double-prism push-pull.

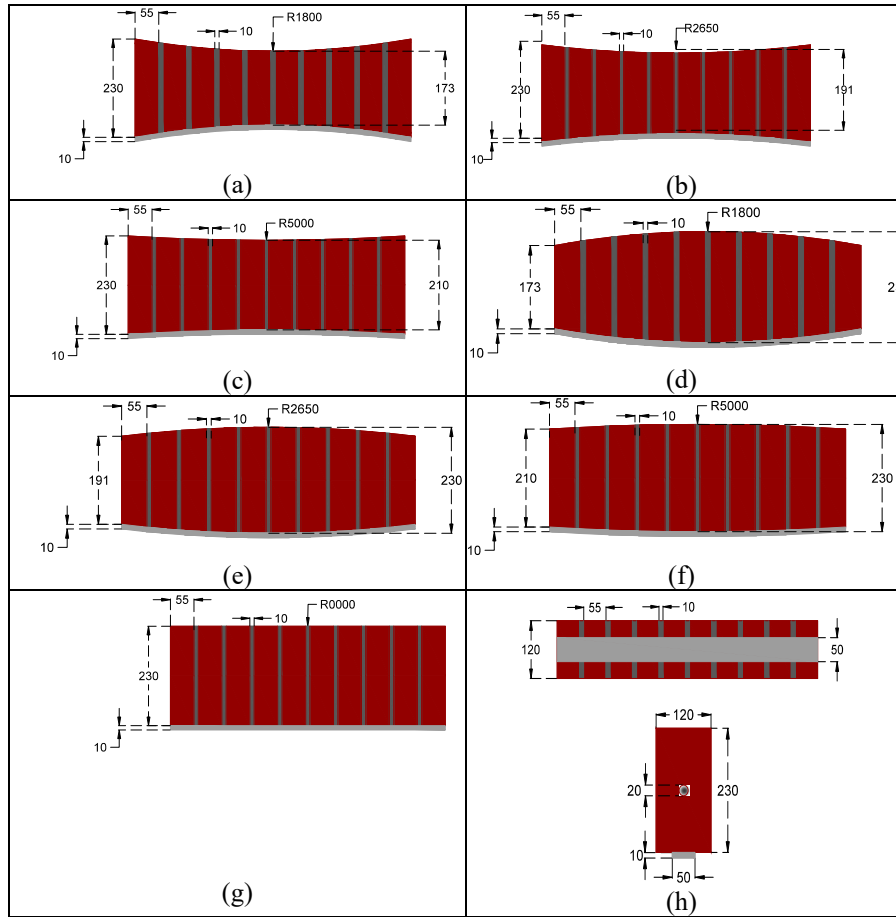
Figure 5.23. Lateral view (a-g) and bottom and side view (h) of the specimens under investigation with concave (a-c), convex (d-f) and plane (g) surface for four-point bending test.

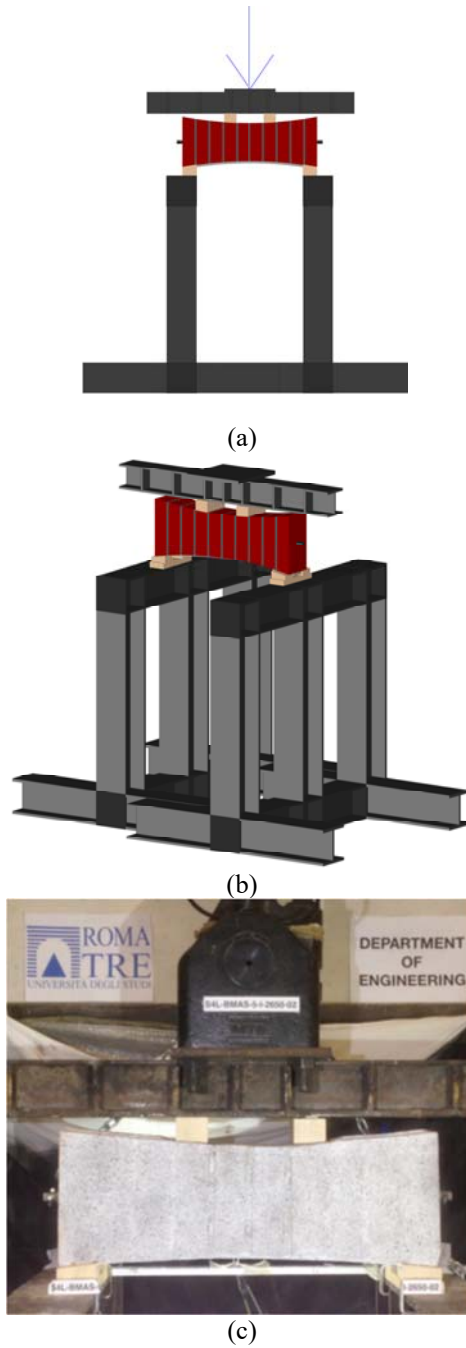
Figure 5.32. Experimental setup, front design(a), axonometric design(b), real image(c)

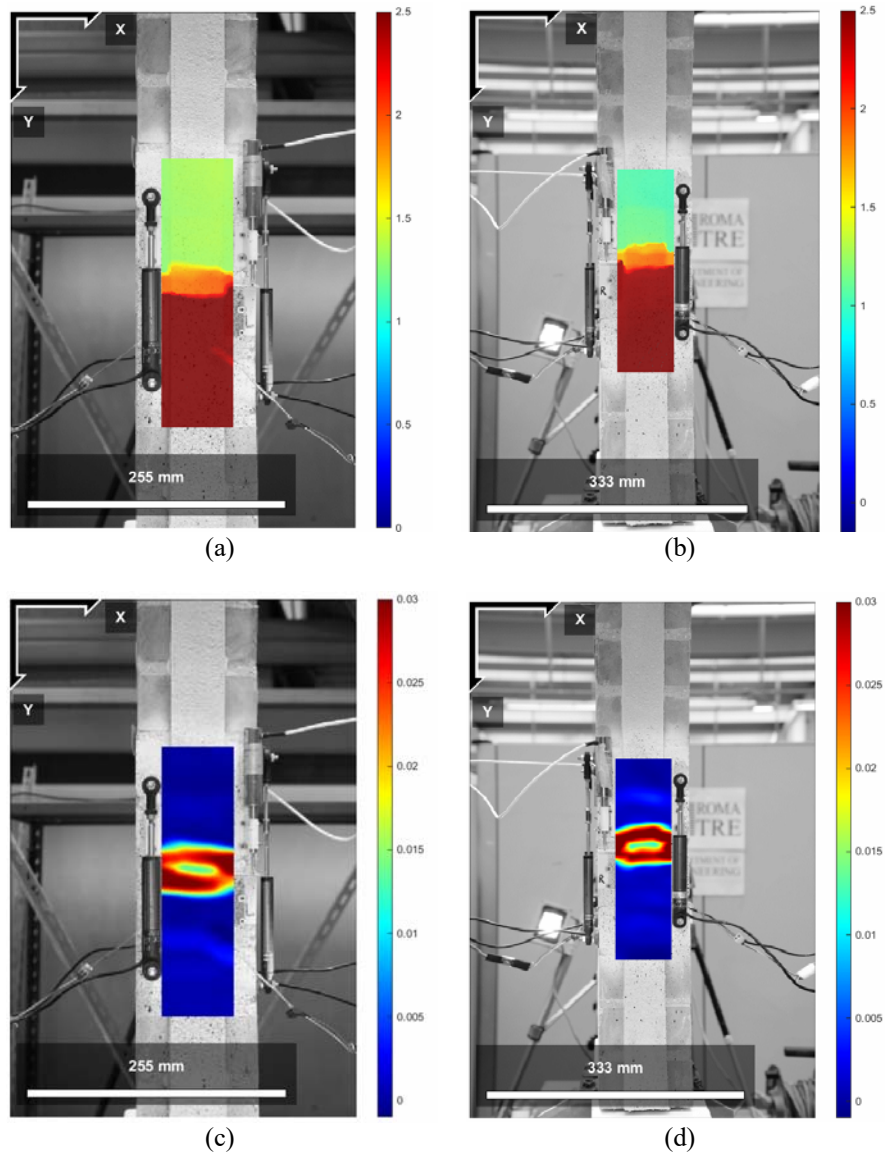
Figure 5.35. Concave test: vertical displacement just before failure, left side(a) and right side(b) and vertical strains just before failure, left side(a) and right side(b).

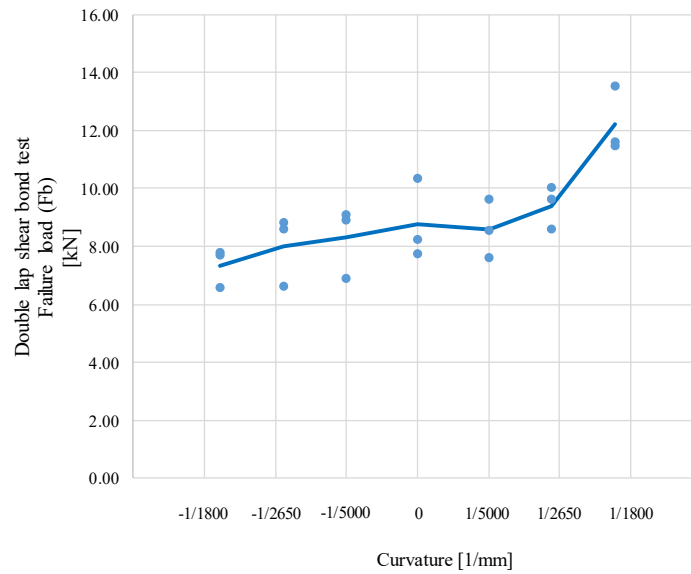
Figure 5.39. Double lap shear bond test failure load vs. curvature

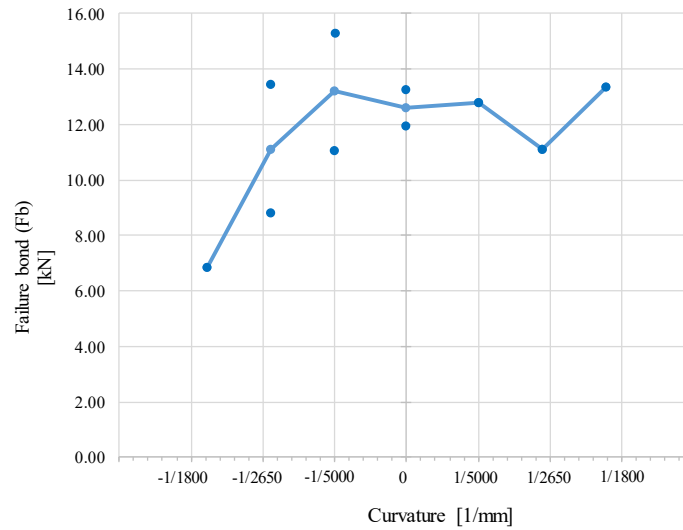
Figure 5.49. Failure load vs. curvature

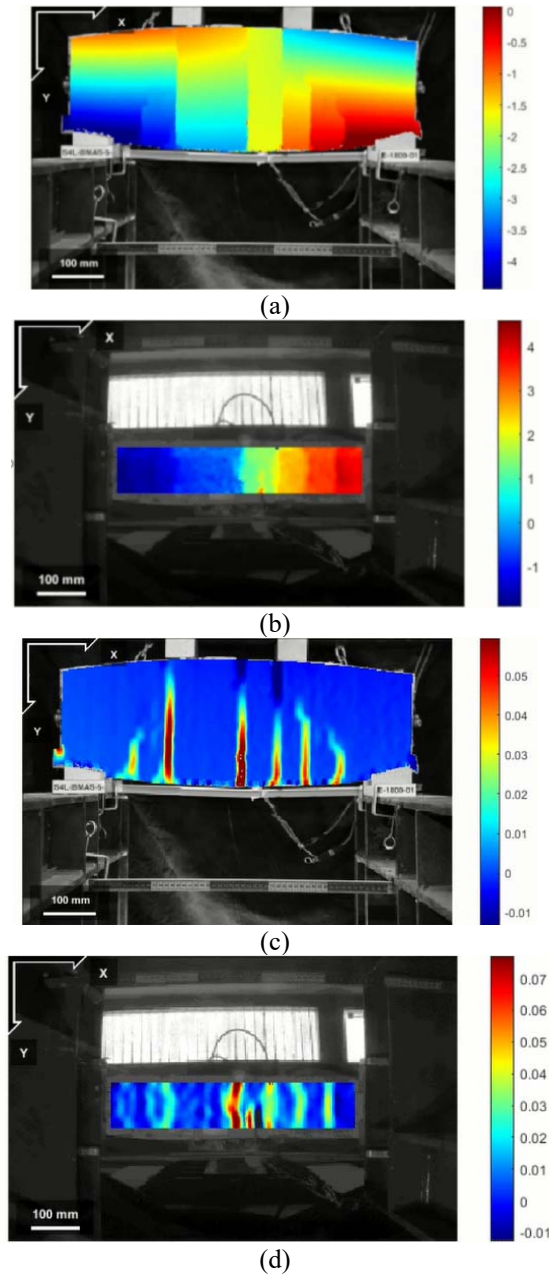
Figure 5.51. Test results provided by DIC: displacement (a,b) and strain (c,d) fields on lateral (a,c) and lower (b,d) surfaces at failure for extradossal specimen E-1800-01

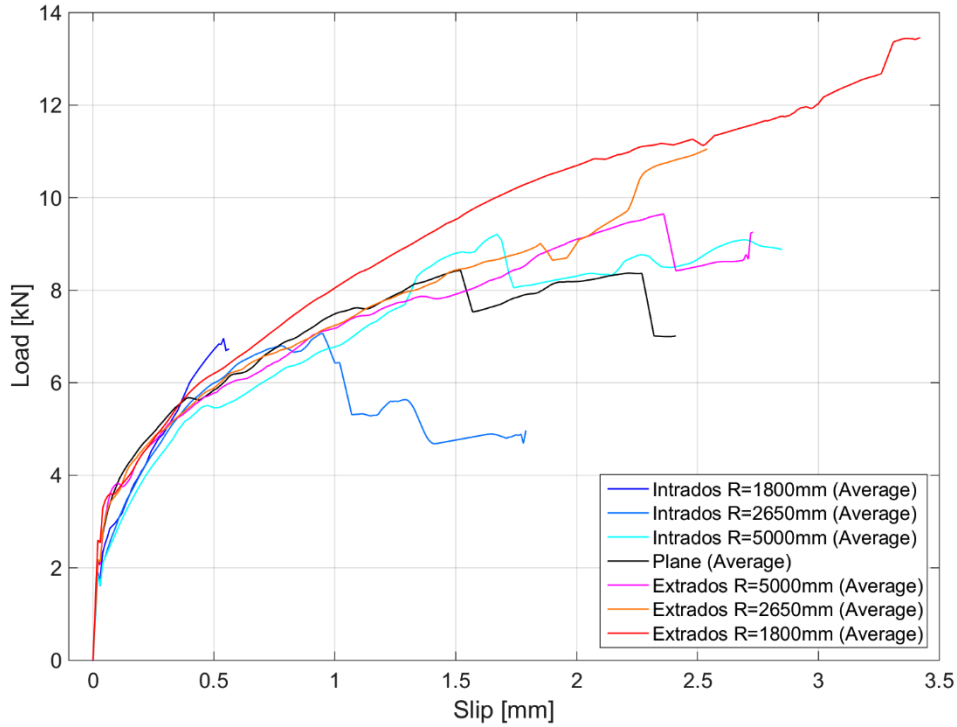
Figure 5.54. Average Load-Slip curve about SRG reinforcement comparing, characterized by different curvature radii.

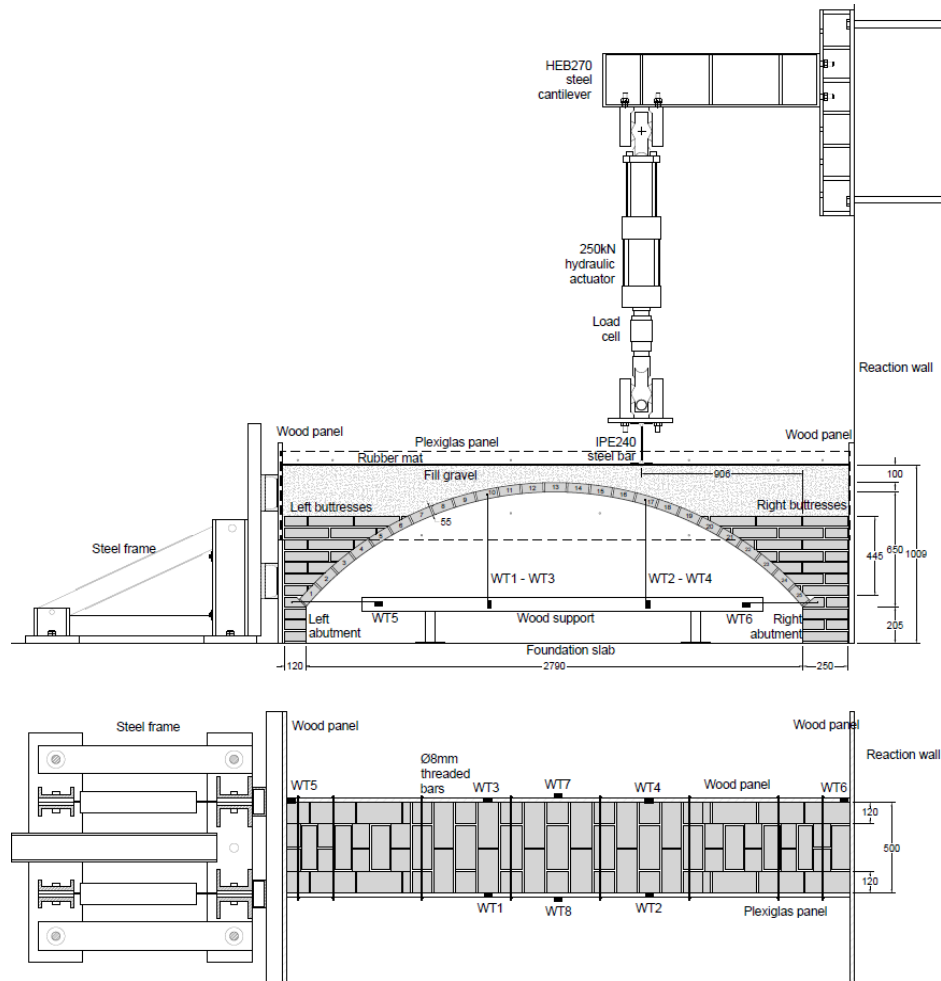
Figure 6.1. Side and top view of the experimental setup.

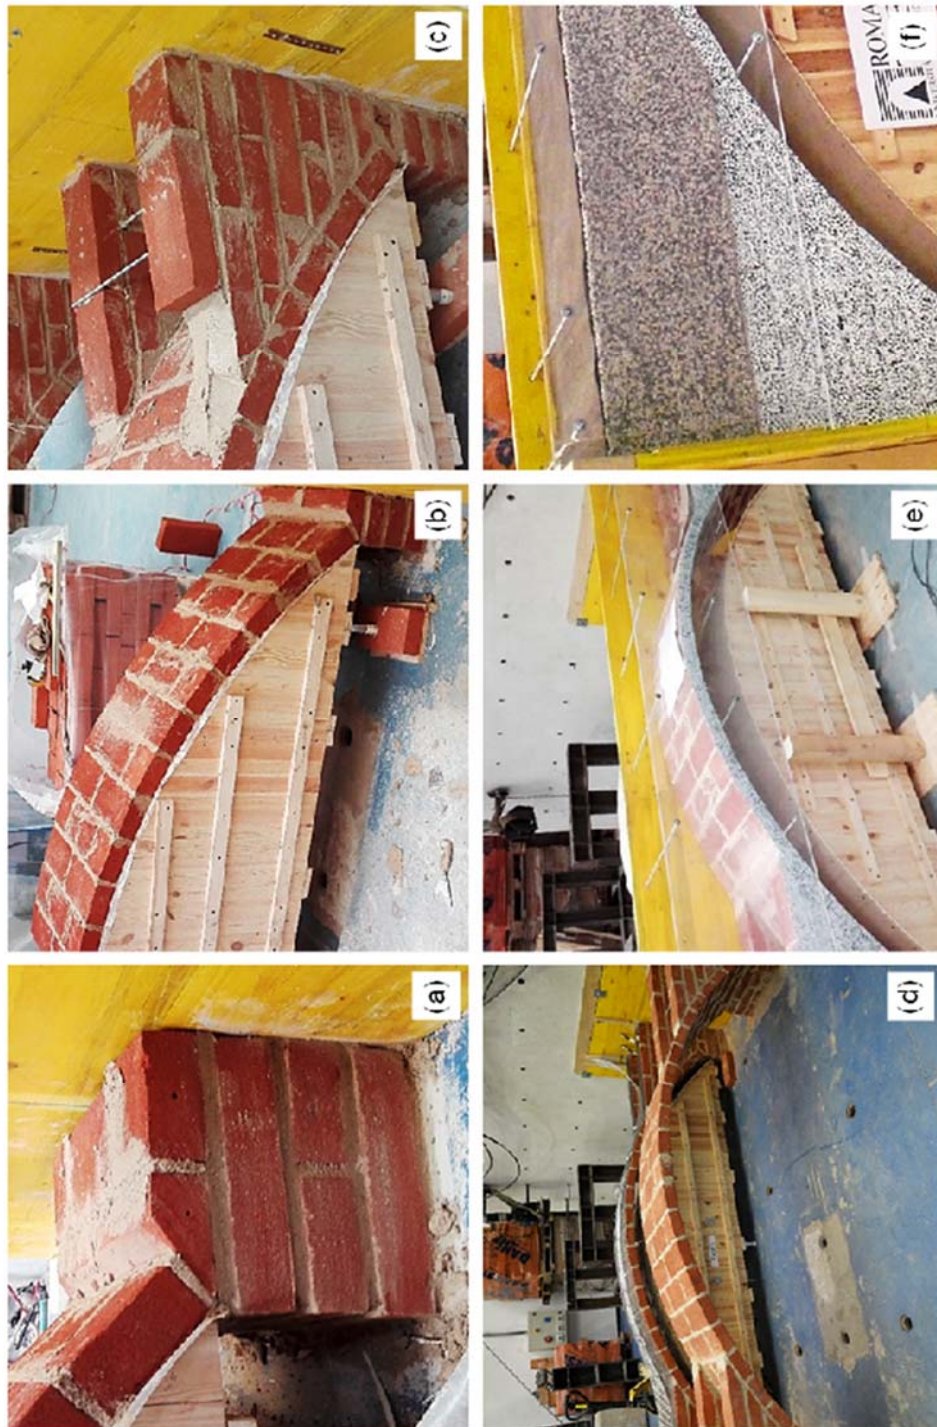
Figure 6.2. Construction of masonry vault specimens.

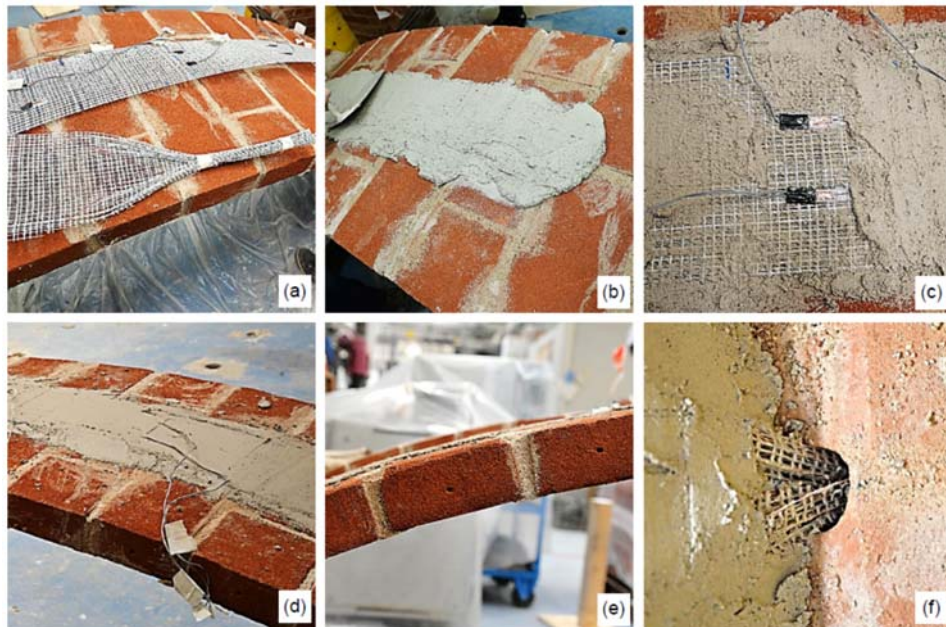
Figure 6.4. Installation of the SRG reinforcement at the extrados of the vault.

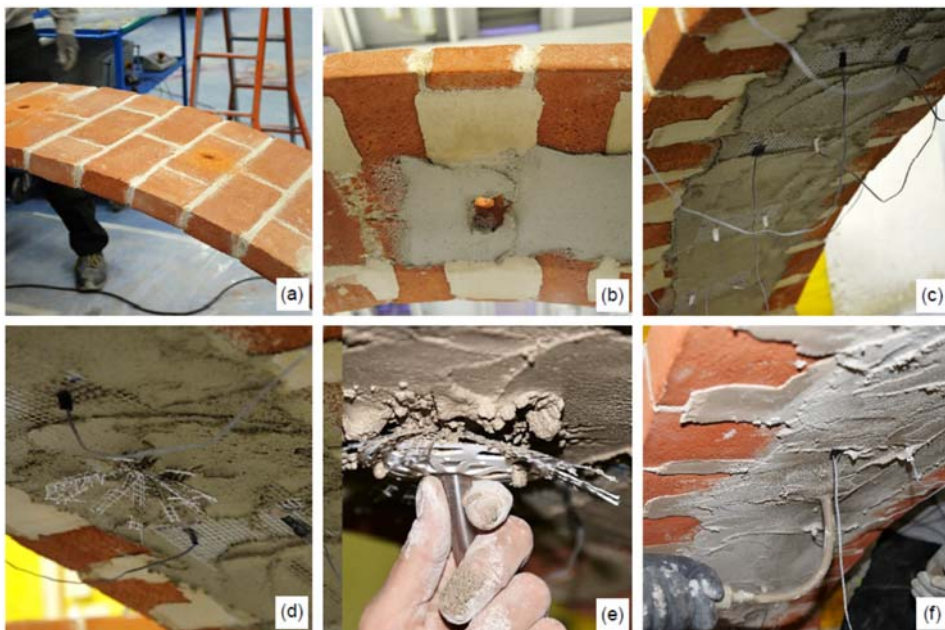
Figure 6.5. Installation of the SRG reinforcement at the intrados of the vault.

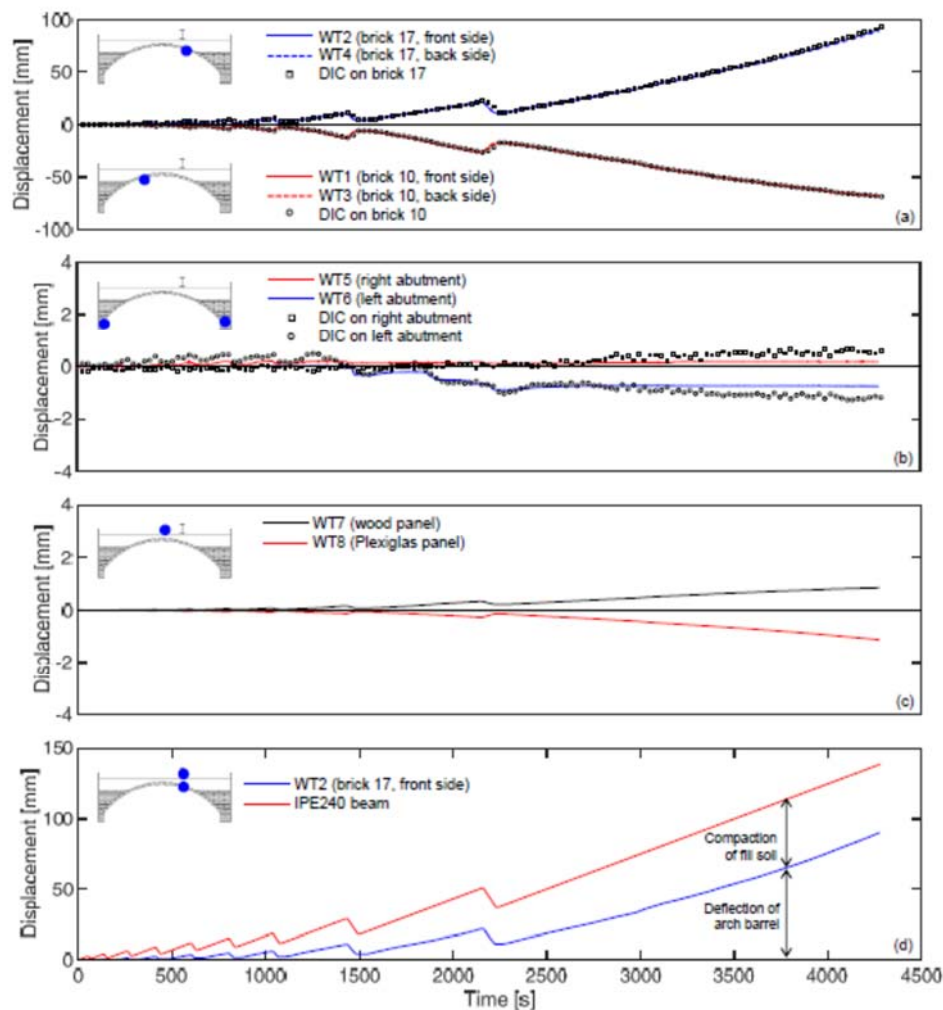
Figure 6.6. Vertical displacements of bricks 10 and 17 (a), horizontal displacements of the abutments (b), out-of-plane displacements of the wood and Plexiglas panels (c), and vertical displacements of brick 17 and of the IPE240 beam (d) vs. time.
