DOTTORATO DI RICERCA IN INGEGNERIA CIVILE

"Strengthening of masonry vaults with Steel Reinforced Grout"

Francesca Roscini

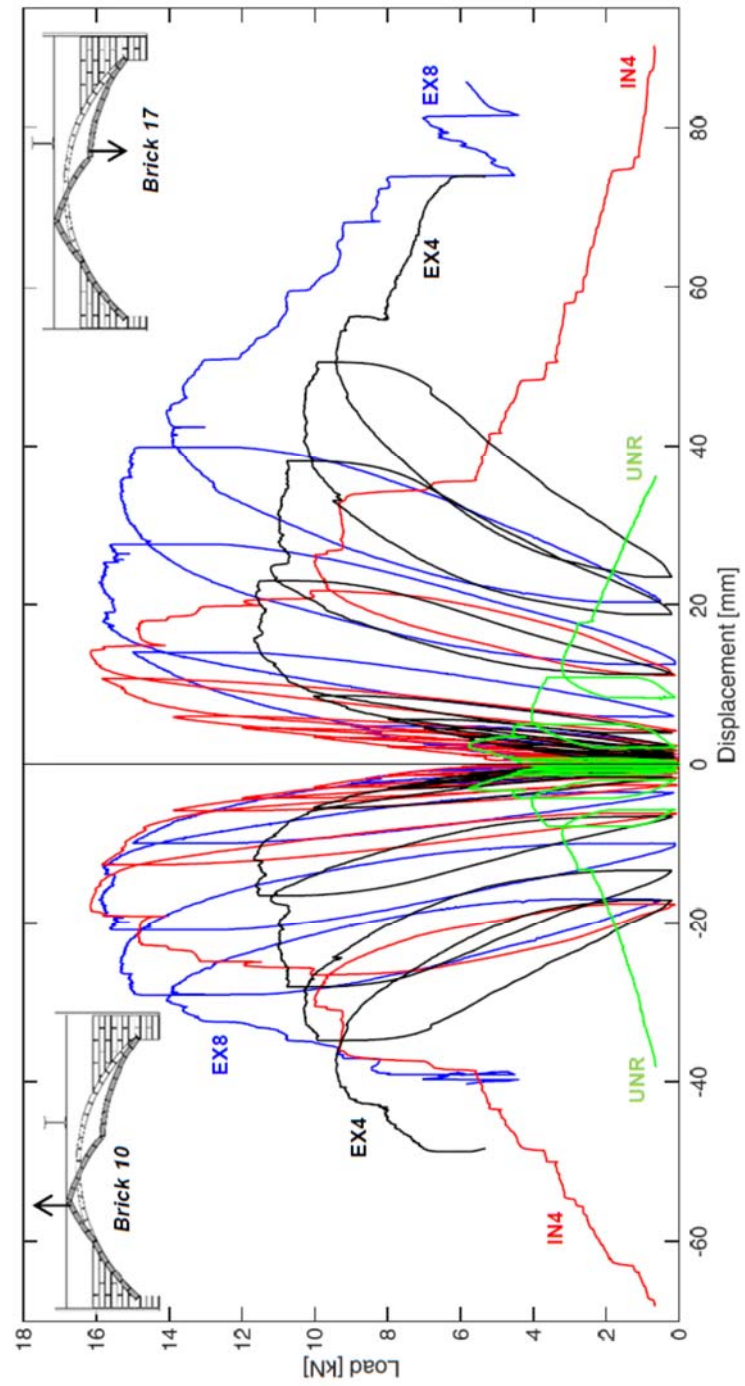
Figure 6.7. Load-displacement response curves.

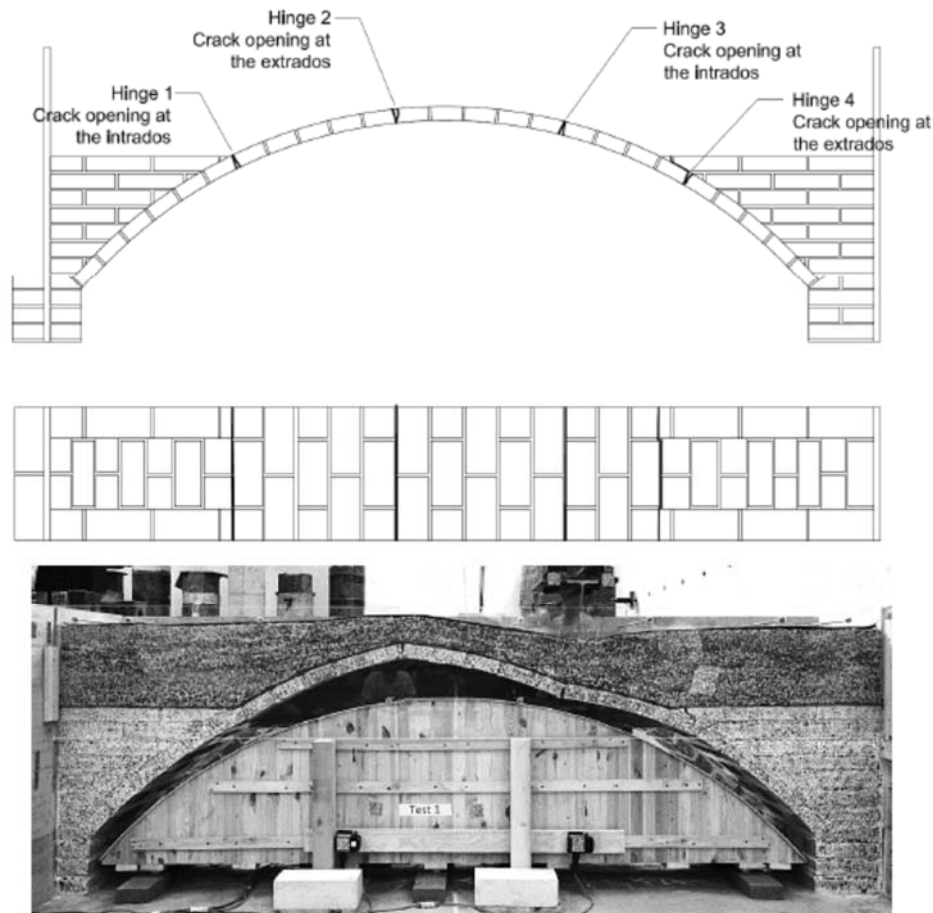
Figure 6.8. Failure mode of UNR specimen.

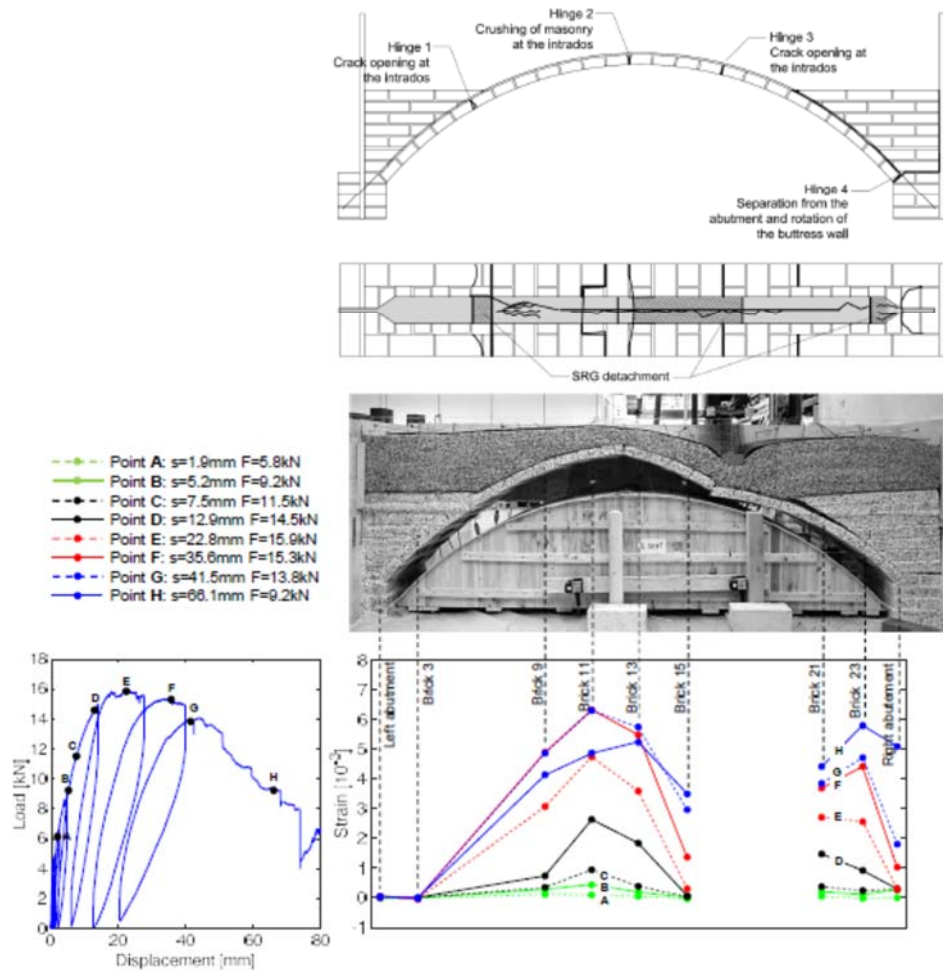
Figure 6.9. Crack pattern, failure mode and strains in the textile of EX8 specimen.

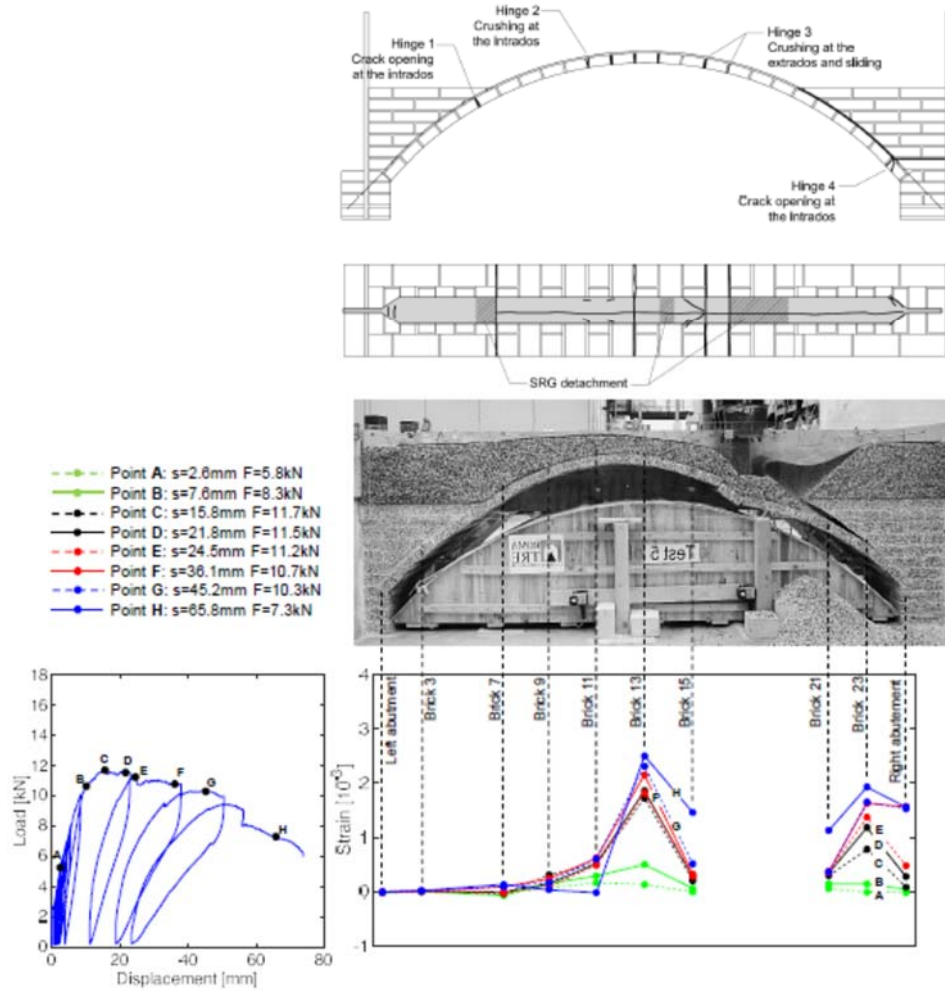
Figure 6.10. Crack pattern, failure mode and strains in the textile for EX4 specimen.

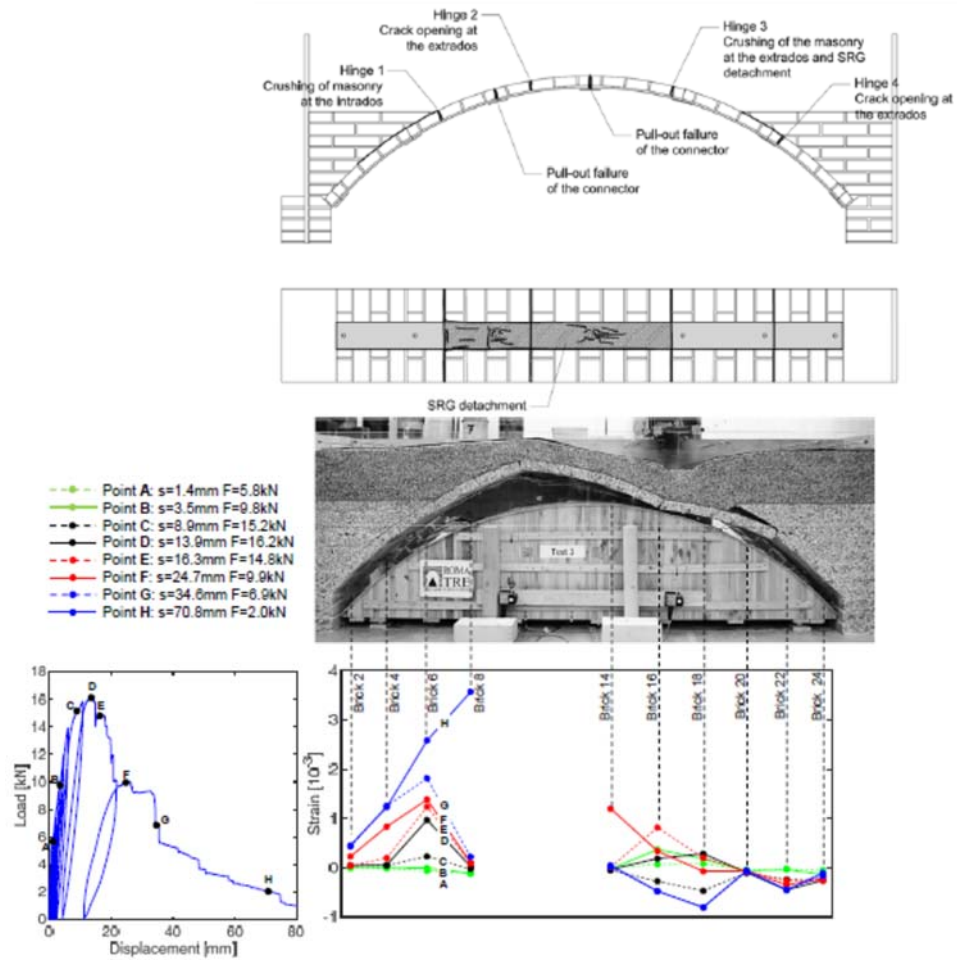
Figure 6.11. Crack pattern, failure mode and strains in the textile for IN4 specimen.

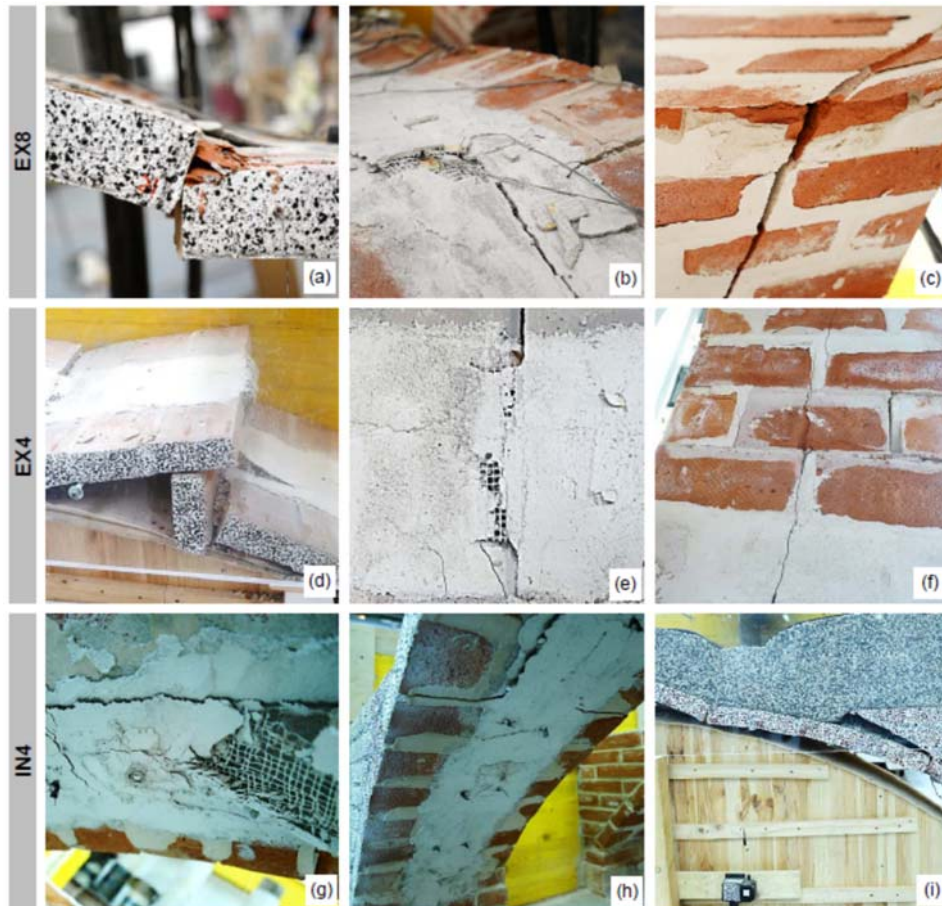
Figure 6.12. Damage pattern surveyed after the test on EX8 (a-c), EX4 (d-f) and IN4 (g-i) vault specimens.

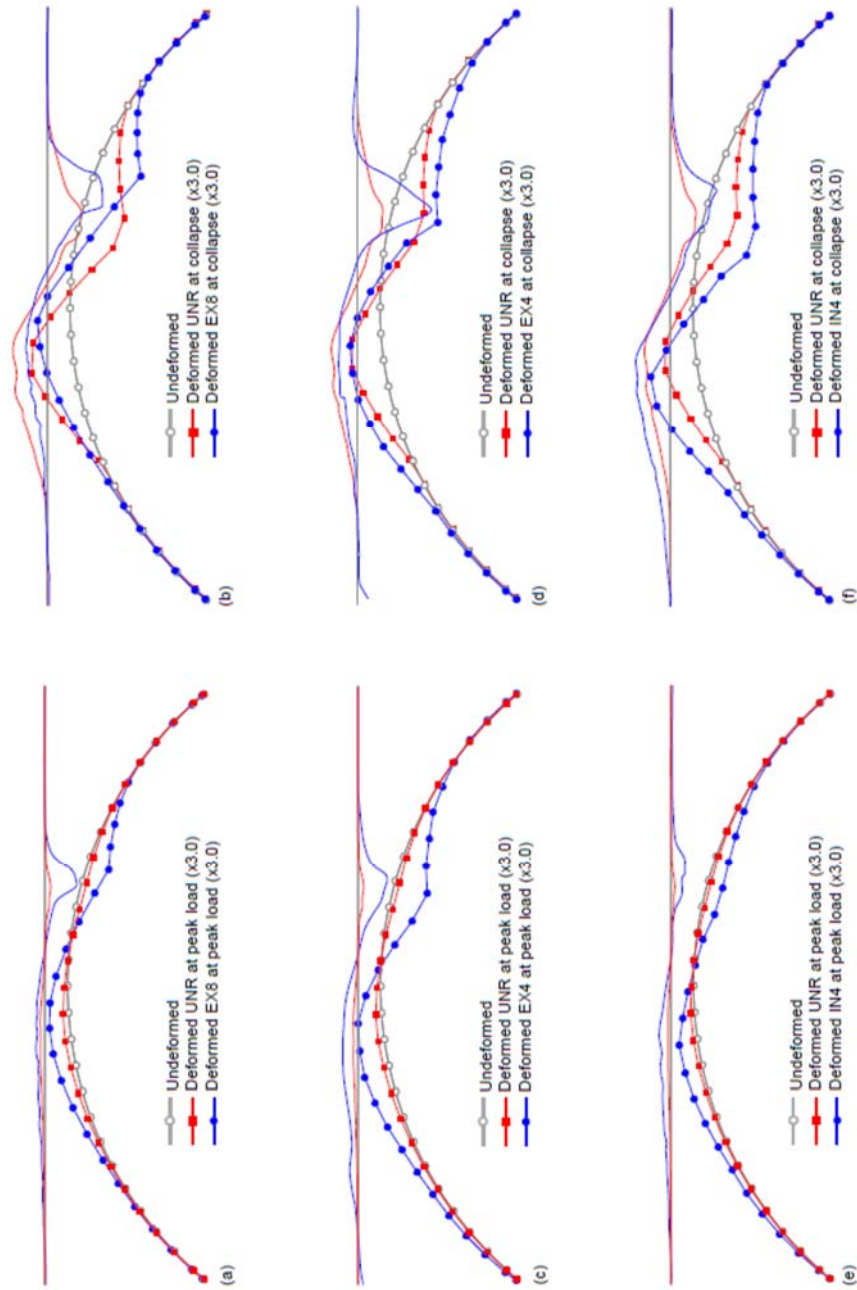
Figure 6.13. Deformed configurations of EX8 (a,b), EX4 (c,d) and IN4 (e,f) specimens compared to those of UNR at peak load (a,c,e) and at collapse (b,d,f).

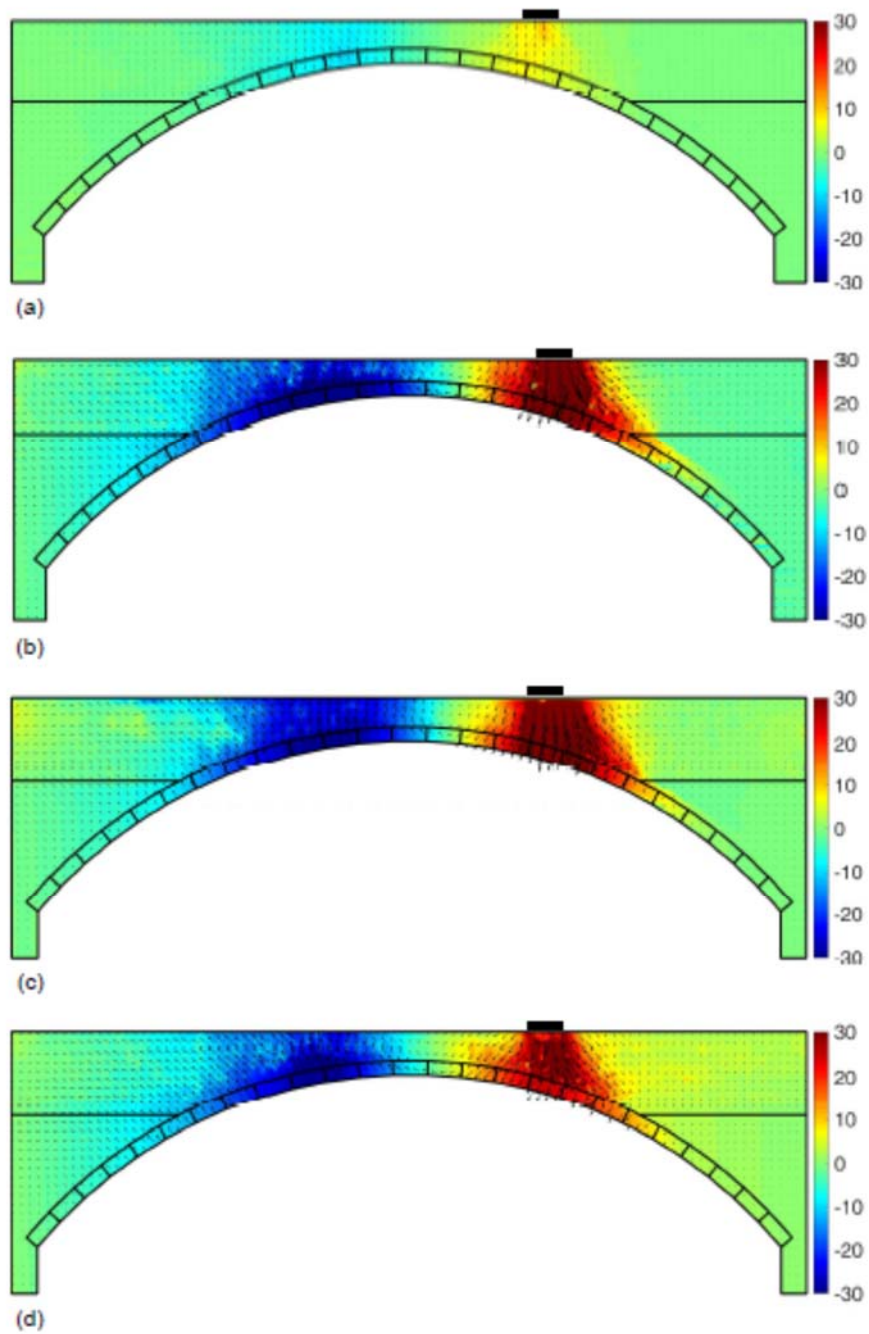
Figure 6.14. Field of vertical displacements and arrows of total displacements at peak load in UNR (a), EX8 (b), EX4 (c) and IN4 (d) specimens. Arrows scaled by 2.

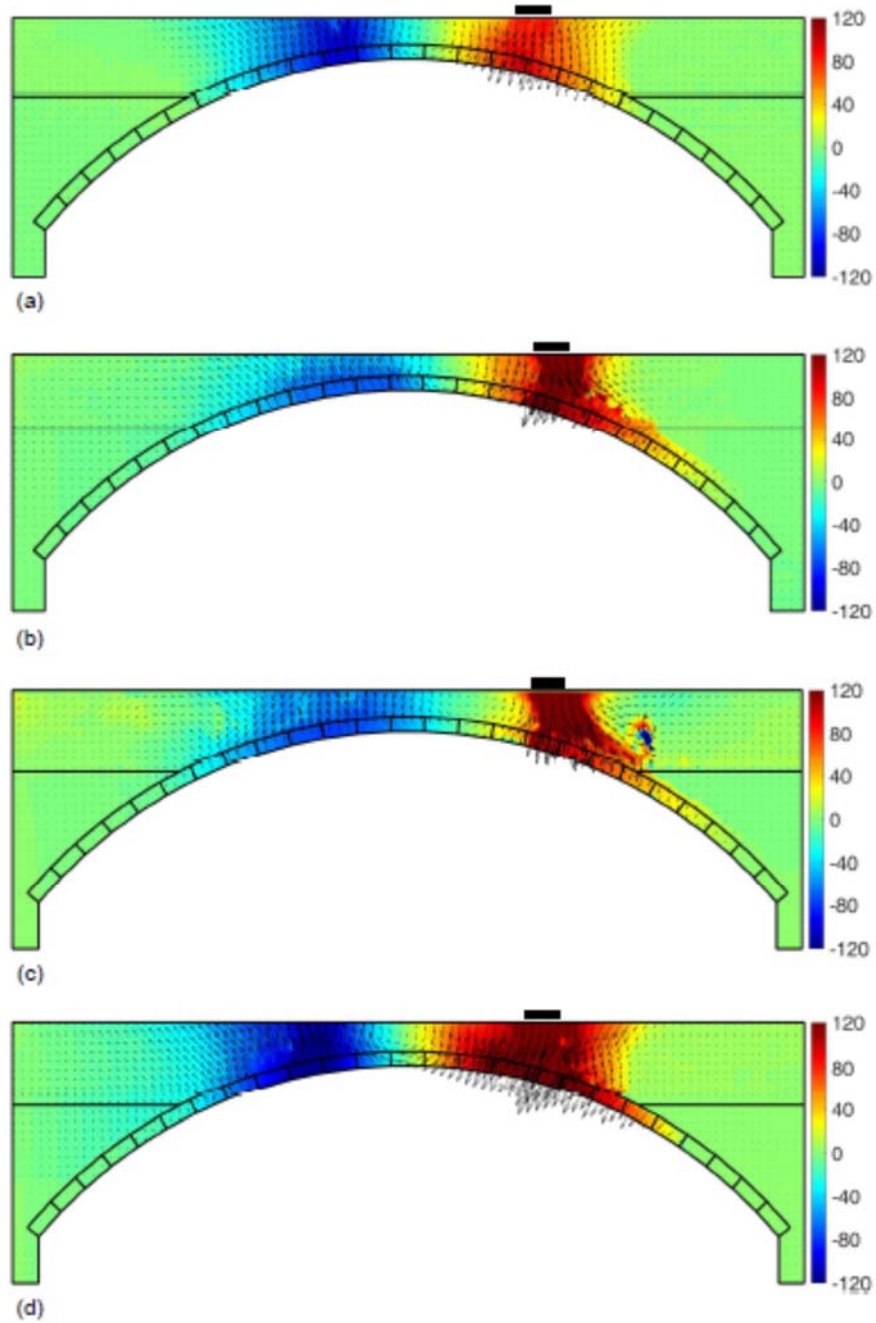
Figure 6.15. Field of vertical displacements and arrows of total displacements at collapse in UNR (a), EX8 (b), EX4 (c) and IN4 (d) specimens. Arrows scaled by 0.8.

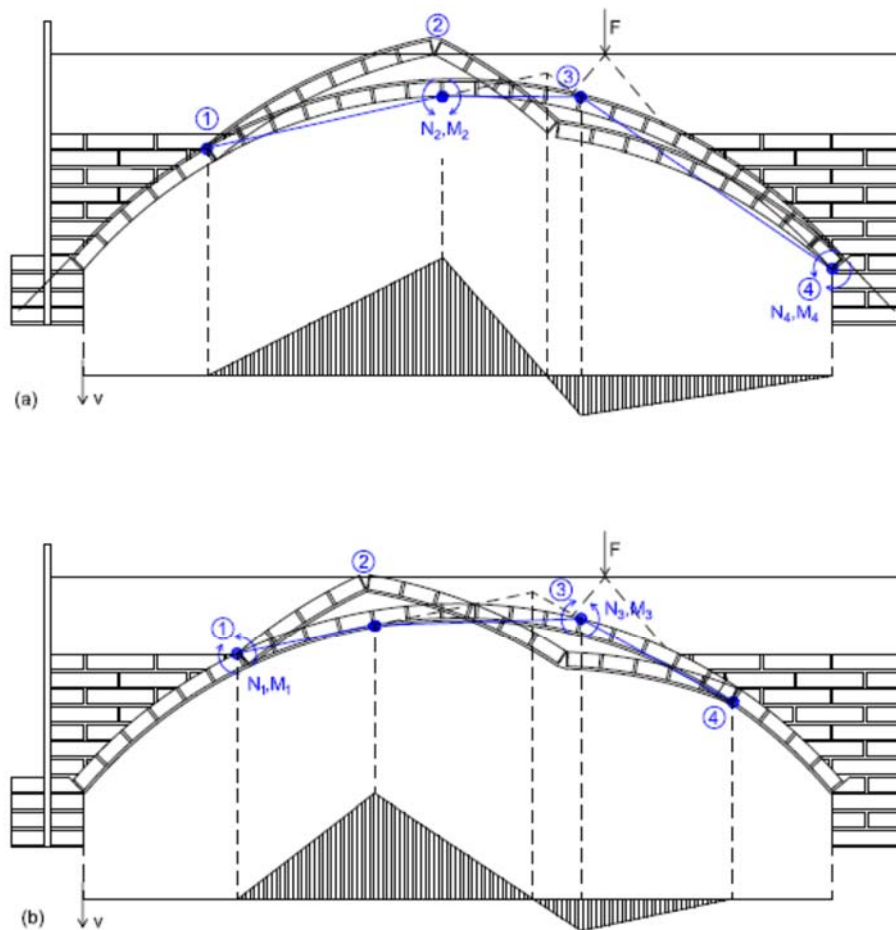
Figure 6.16. Collapse mechanisms of EX8 (a) and IN4 (b) specimens used for the analytical estimate of their load carrying capacity with limit analysis based approaches.

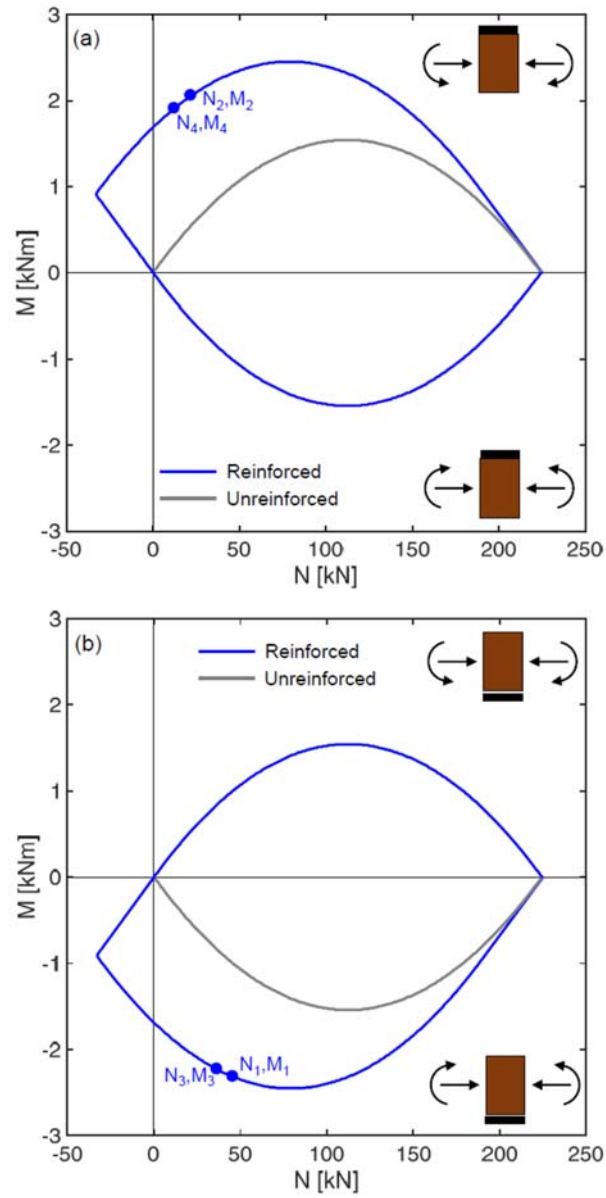
Figure 6.17. Axial load – bending moment strength domains of the cross section of the arch reinforced at the extrados (a) and at the intrados (b).
