### GENERAL INFORMATION

Name of the project: Laurentino38, Roma (South)  
Design group: P. Barucci, A. De Rossi, L. Giovannini, C. Nucci, A. Sostegni  
Client: I.A.C.P. (now ATER Roma)

Construction: 1972 - 1983  
Sector: 100% social rented dwellings

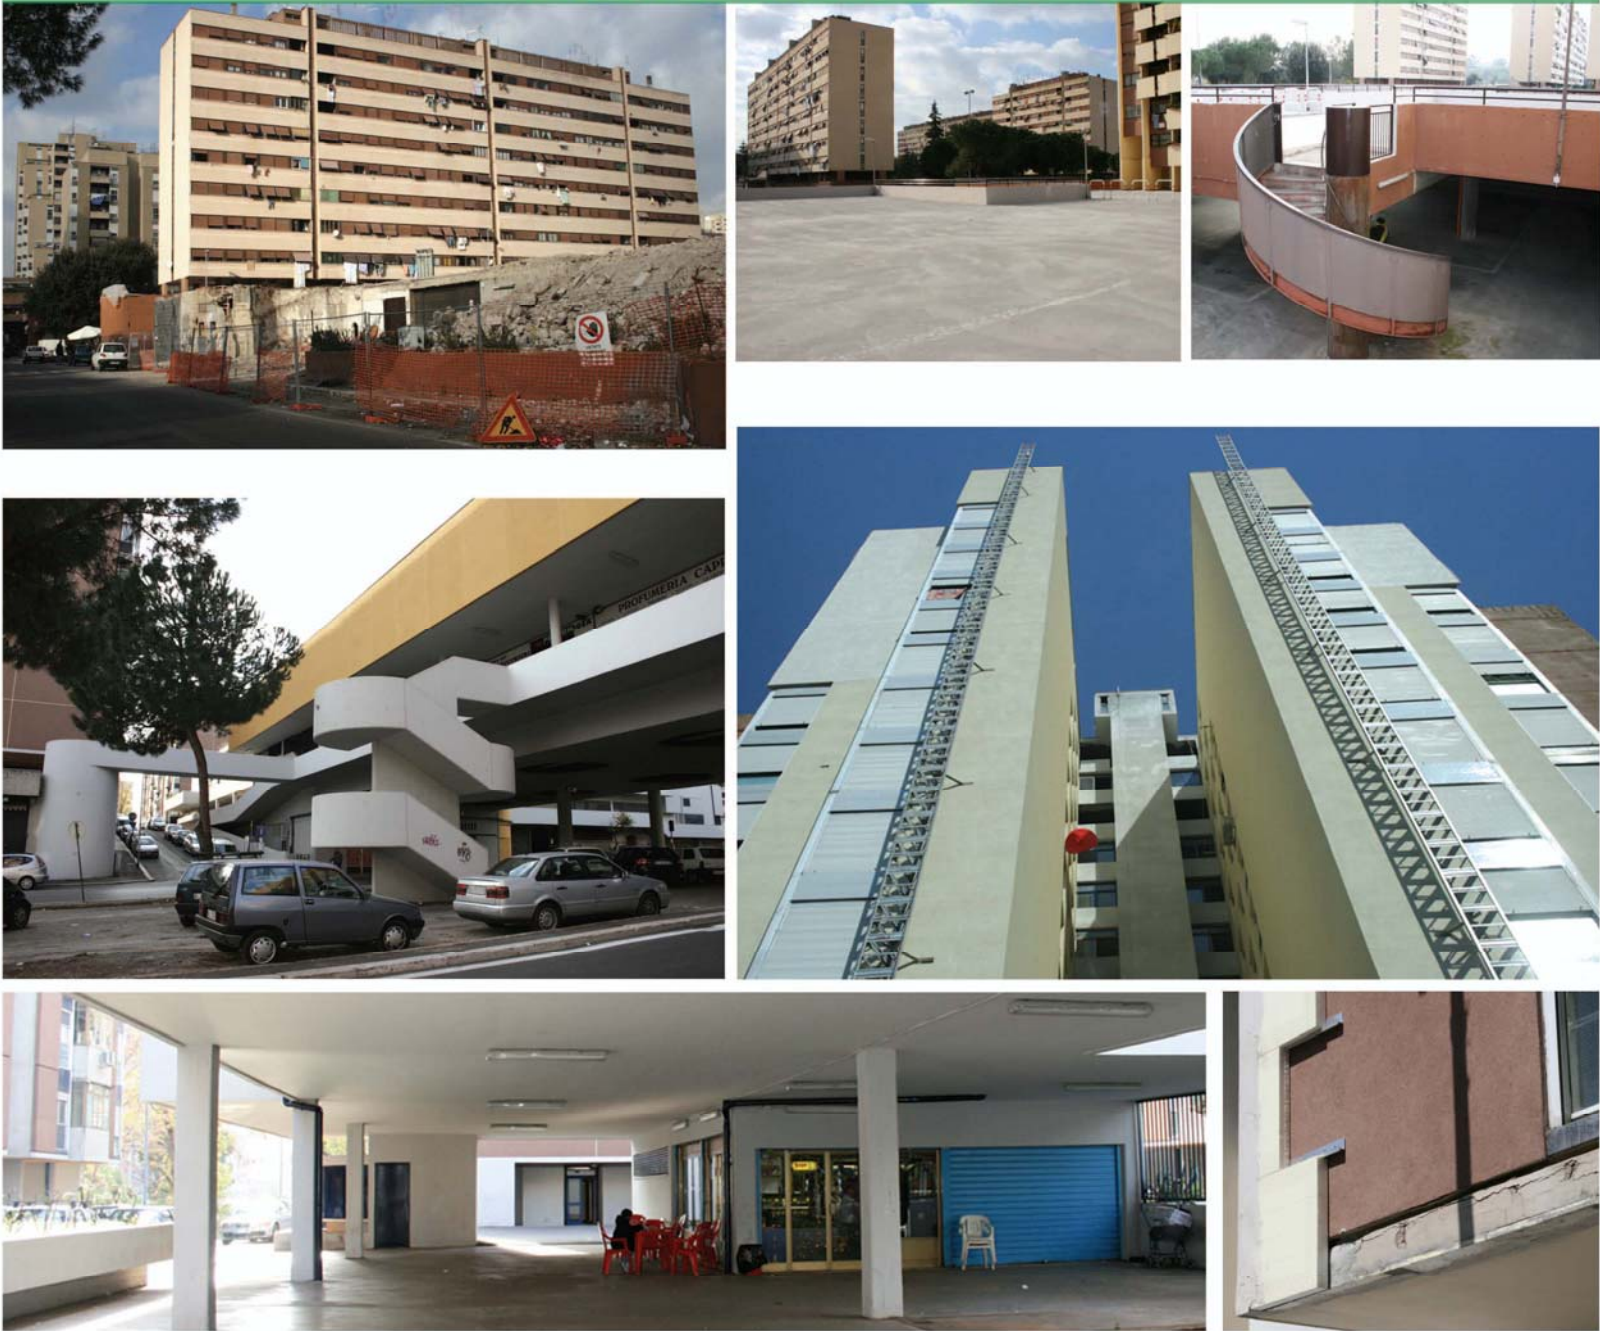
In some cases demolition of some bridges improved social and urban quality of the respective insula. Other bridges have been renovated by paintings with recognizable colors. This intervention attracted a few small commercial activities. The facade of the blocks owned by the cooperatives have been renovated by fixing a new cladding with insulation on the outside.
